# FASSET Refurbishment

DRDC Ottawa TM 2004-134

July 2004

This report covers the significant refurbishment events including items repaired, modifications and improvements, and unresolved problems. It provides a technical reference of knowledge collected as well as a record and explanation of refurbishment events. Other topics covered include test equipment, maintenance procedures, lessons learned, and future work.

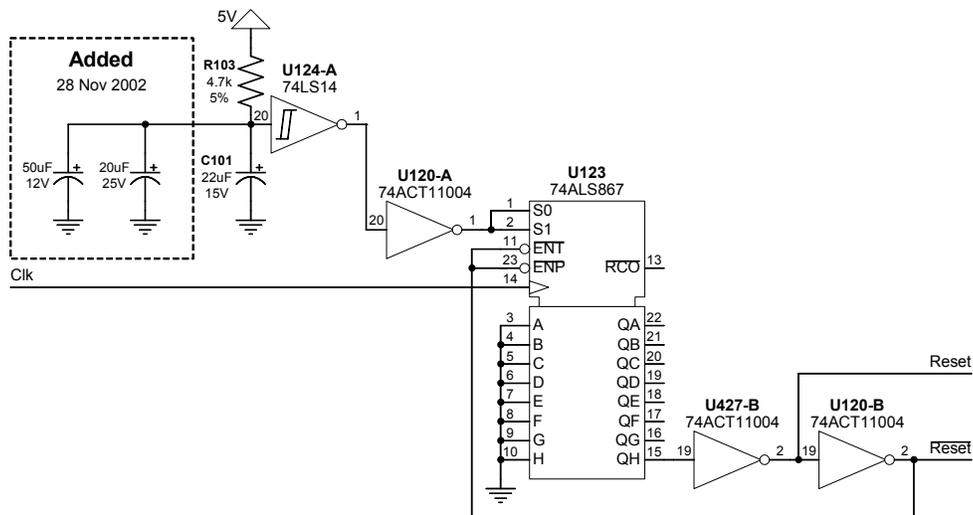
**Figure 4 Payload Transmitter Subsystem DIU reset circuit**

A logic analyzer was used to probe the RAMs of the processor in the DIU. This allowed inspection of the data and addresses used during execution. It was determined that the DIU processor was in a non-code area of the address space. This could have been caused by a bug in a properly running program, failed hardware or by an improper reset. Since the DIU was previously functioning properly, the reset hypothesis was tried first. By grounding out the power-up capacitor, the board was artificially reset. This caused the DIU to work normally. It was felt that the aging power supplies were coming up slower than originally designed and the time constant of the reset was no longer long enough.

By quadrupling the capacitance, the time constant of the circuit was lengthened. This solved the power-up problem. The final diagram of the reset circuit is shown in Figure 4.

Since power-up problems have been seen occasionally in other subsystems, this problem may have occurred in other DIUs. If other subsystems fail in the same manner, then their reset circuit time constant should be lengthened accordingly.

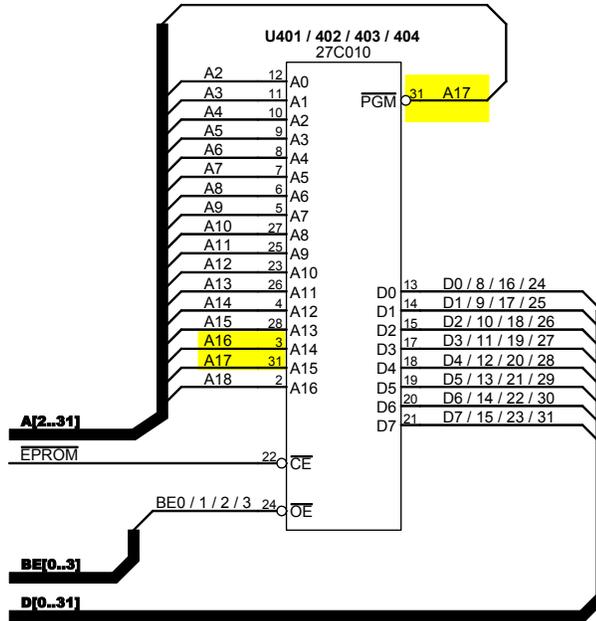
**Figure 5 Extract from original PCI EPROM wiring diagram**

It was found that the assignment of pin 29 to EPROM address line A14 was indeed correct as per the data sheet for the device, however there were corresponding errors in the PCI schematic for each EPROM socket. There was no connection made from CPU address line 16 to pin 29 of any of the EPROMS, corresponding to EPROM address line A14. It was also found that two other address lines were incorrectly connected to the EPROMs. CPU address line A16 is shown incorrectly connected to pin 3 on each EPROM, which is actually EPROM A15, instead of the intended EPROM A14 on pin 29. CPU address line A17 is incorrectly connected to pin 31 on each EPROM, which is actually the /PGM pin, instead of the intended EPROM A15 on pin 3. Figure 5 is an extract from [15], drawing #112709, sheet 4 of 8. It shows the problem connections highlighted on a diagram representing the four EPROMs with a single sketch. Note that EPROM U401 is associated with data lines D0-D7 plus chip select line BE0. Similarly, U402 is associated with D8-D15 plus BE1, U403 with D16-D23 plus BE2, and U404 with D24-D31 plus BE3.

Analysis showed that the error in connecting CPU address line 17 to the /PGM pin of each would have no effect on the functioning of the EPROMs as long as no programming voltages were supplied to the chips.

Further analysis showed that the error in connecting CPU address line 16 to the A15 pin of each EPROM did not cause a malfunction because the upper portion of the EPROM address space represented by A15 = “1” was unused. It could never be addressed because the CPU A16 line was always a “0” when addressing the EPROMs. Figure 6 is a similar diagram to Figure 5, and shows the wiring errors that were found, with corrected labels applied to pins 3, 29 and 31. The modification to ground the floating A14 line on pin 29 of each EPROM is also shown.

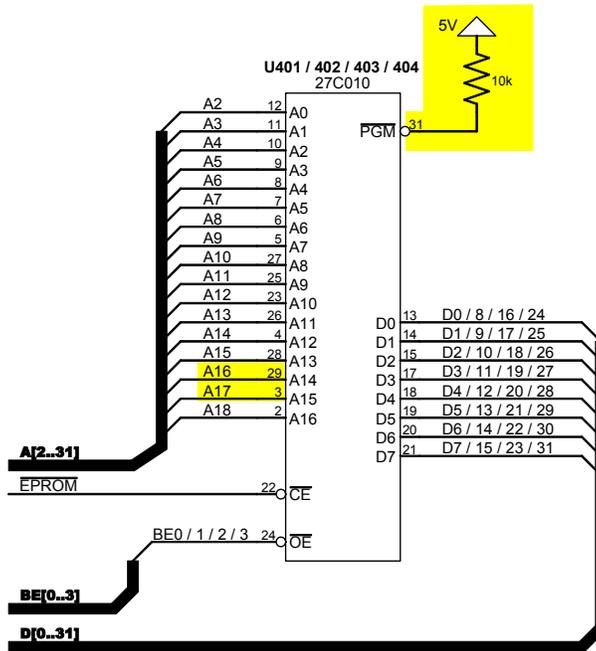
**Figure 7 EPROM diagram with recommended final modifications**

It should be noted that the PCI EPROM circuit repairs discussed in this section are only temporary, and do not actually correct the address line wiring errors. This could represent a serious problem if the PCI firmware had to be modified, and expanded to a point where it occupied a larger portion of the EPROM address space. The proper and permanent modifications required for the PCI circuit board are shown highlighted in Figure 7, and are included in Section 5.6 as recommendations for future work.

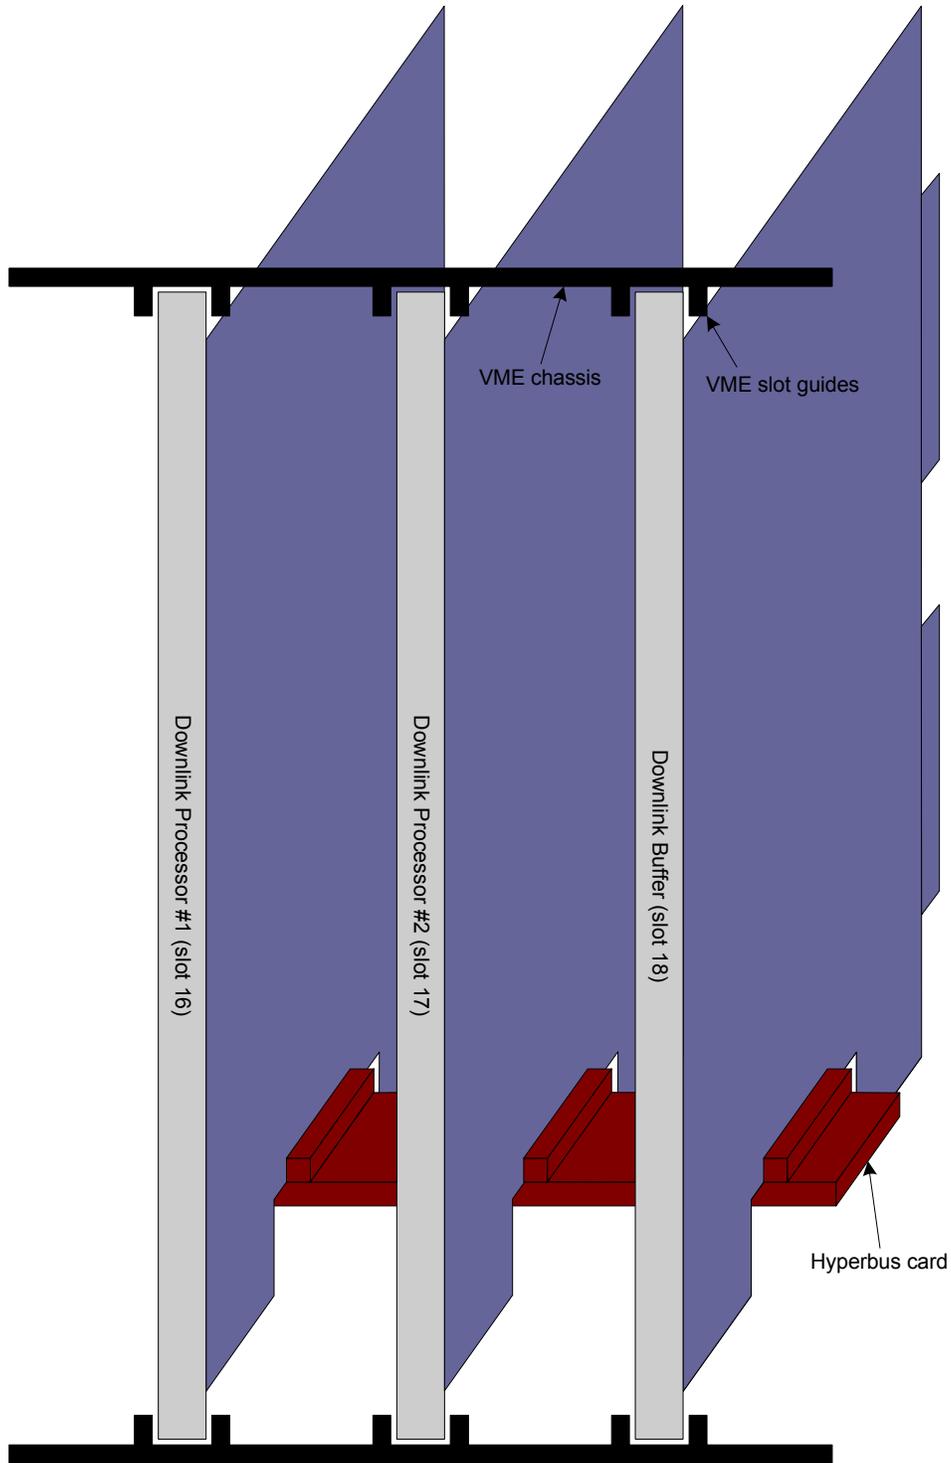
**Figure 10 Physical layout of the Hyperbus (front view)**

When FASSET was being prepared for delivery to Harris Corporation, all of the ground terminal boards were removed and catalogued. To read the serial numbers of the Downlink Processors and the Downlink Buffer, the Hyperbus had to be disassembled at a laboratory bench. Prior to the cataloguing, the three Hyperbus connections were solid, as they had been attached for several years. After being disturbed during cataloguing and during shipment, the Hyperbus connector became loose. Upon first power-up, the ground terminal produced a slight burning odour that lasted a couple of minutes. The source of the smoke was difficult to locate, but after a thorough search, the Hyperbus circuit board was found to be loose. Although no burn marks were evident upon inspection of the Hyperbus, it was suspected as the source of the smoke, because once it was tightened the overheating stopped and the ground terminal start-up proceeded normally. Successive power-ups yielded no further problems from the Hyperbus, although a loose connector was later suspected when downlink synchronization problems began to become prevalent during emulations (see Section 3.3.6). That problem was eventually linked to a failure in the Frequency Reference Generator.

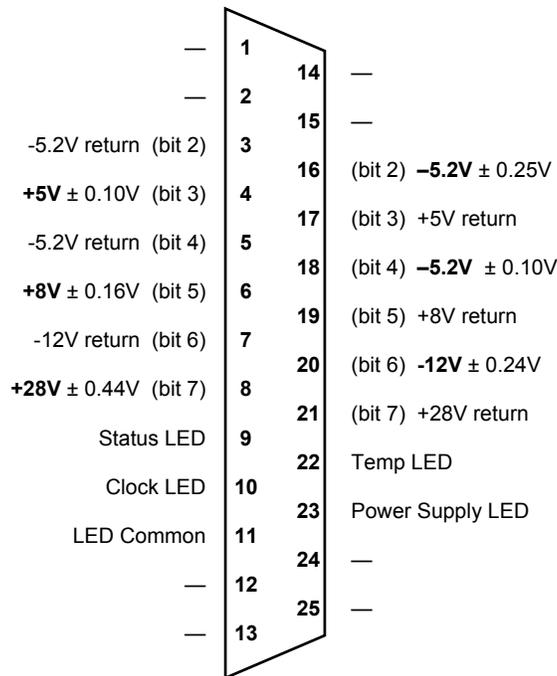
**Figure 11 Payload TCS power supply monitor**

The TCS is a densely packed subsystem with modules and cables that are worn by age and from past manipulation. The power supply section is especially troublesome as it is organised into two vertical layers. The top layer of power supplies can be removed, with difficulty, for access to the supplies below. Once the top layer is disconnected and removed from the TCS, it is no longer available for simultaneous testing in combination with the lower layer. In order to ease the monitoring of power supplies in the TCS, the monitor port in Figure 11 was installed on the rear panel of the TCS, and an intercept cable was placed in line with the J3 connector of the PCI module. This monitor cable allows the operator to measure all of the power supplies in the TCS with external probes. This is a significant improvement to the former situation where a significant amount of agitation was incurred on the internal harnesses and cabling each time a power supply failure was investigated.

After training, the replacement 12 V power supply in the Timing Control Subsystem began to behave strangely and had to be replaced. At the same time, an external monitor port was added to provide the capability of measuring internal power supply levels without disassembling the system.
