CANADIAN POLICE RESEARCH CENTRE

TR-03-2002

Resistance of Exterior Walls to High Velocity Projectiles

TECHNICAL REPORT
February, 2002

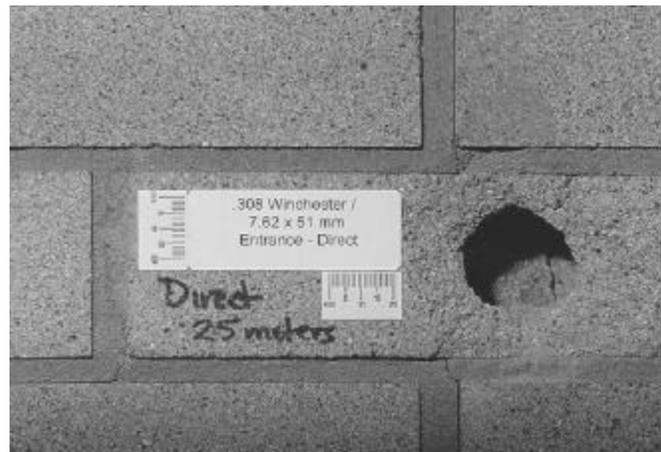
Figure 3 - Damage to clay brick caused by .308 Winchester

The .308 Winchester bullet produced a chip approximate 80 mm wide by 55 mm high from the brick. In addition, a 35 mm diameter hole was produced to a depth of about two thirds the brick thickness. The mortar was cracked around the perimeter of the brick. Figure 3 shows the damage caused by the .308 bullet.

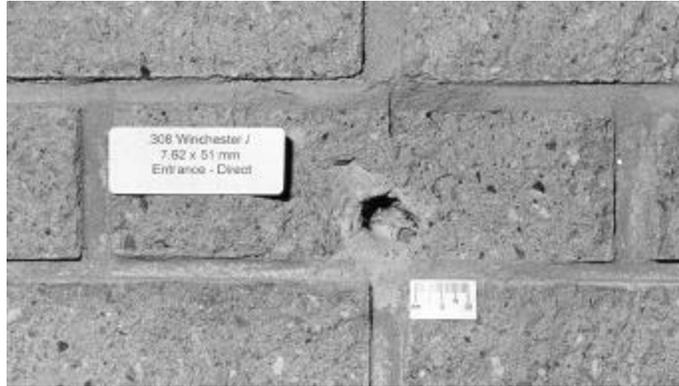
Figure 4 - Damage to concrete brick caused by .308 Winchester

The .308 Winchester bullet removed a region approximately 100 mm wide by 55 mm high. The hole was 25 mm by 20 mm to a depth of approximately half the brick thickness. This damage is shown in Figure 4.

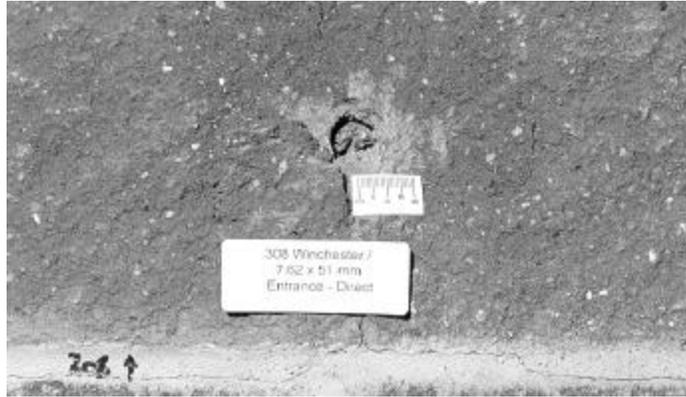
Figure 5 - Damage to red concrete masonry units caused by .308 Winchester

The .308 Winchester bullet displaced a portion of the block approximately 40 mm in diameter. It left a hole approximately 21 mm in diameter and 13 deep as shown in Figure 5. The unit was also cracked from top to bottom with the fracture plane running through the hole.

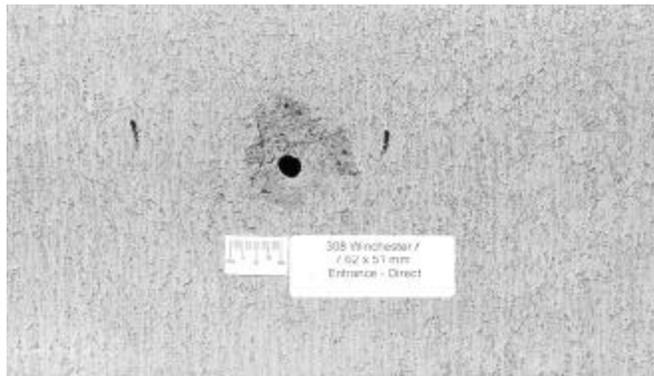
Figure 6 - Damage to the 140 mm concrete block wall caused by .308 Winchester

The .308 Winchester bullet penetrated both the front and rear face shells of the concrete block, passed completely through the foam insulation, and came to rest against the clay brick. It left a chip approximately 28 mm in diameter and hole approximately 10 mm in diameter. The entrance hole is shown in Figure 6.
