CORROSION PROBLEMS WITH COPPER-NICKEL COMPONENTS IN SEA WATER SYSTEMS

D. R. Lenard and R. R. Welland
Defence Research Establishment Atlantic
Esquimalt Defence Research Detachment
CFB ESQUIMALT
PO BOX 17000 STN FORCES
VICTORIA BC V9A 7N2

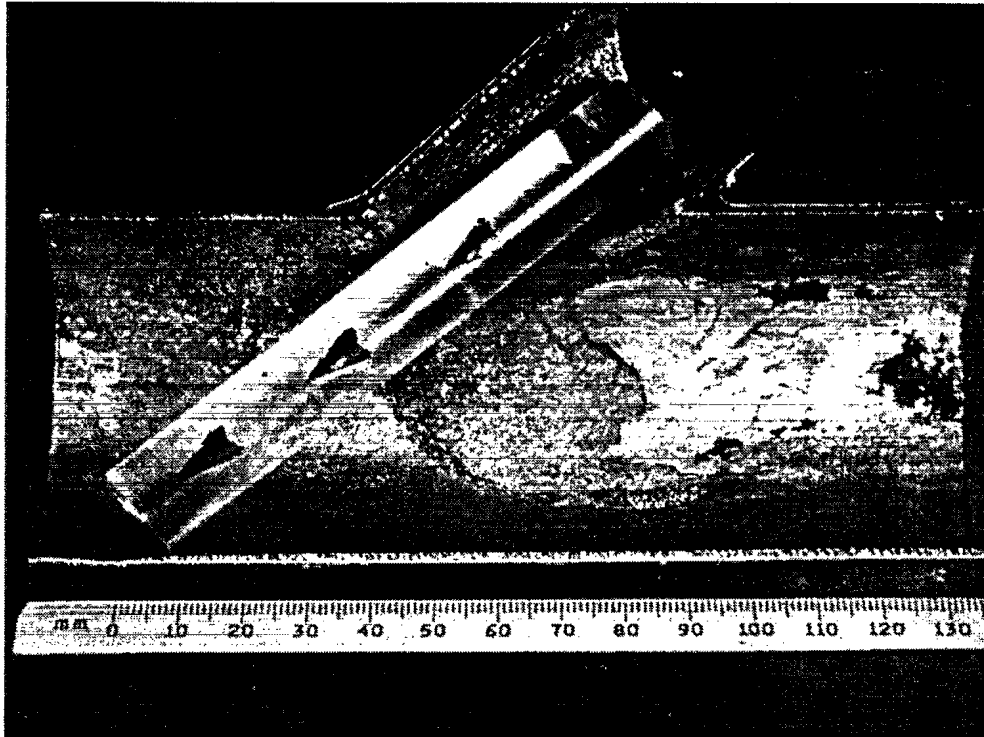
Sea water systems using 90/10 copper nickel (UNS C70600) piping have provided many years of reliable service in surface ships operated by the Canadian Forces. Very few failures of this piping have been brought to the attention of either of the Dockyard Laboratories (this one in Esquimalt, BC or the other in Halifax, NS). Most of these failures have involved erosion corrosion caused by unintentional obstructions at flanges or by modifications to the piping systems to accommodate new equipment or operational procedures. An example of the latter involves a blackwater piping system that had been in service since 1964. The 90/10 copper nickel pipe shown in Figure 1 perforated in 1992 as a result of erosion corrosion near the exit of the small discharge pipe from one of the crew's heads. The system had originally been designed for sea water-flushed overboard discharge. However, in 1985, the blackwater system was adapted to accommodate vacuum collection into a holding tank. The changes in velocities and composition of the effluent resulting from this conversion caused erosion corrosion of the original copper nickel collection pipes.

Figure 1. Erosion corrosion of 90/10 Cu-Ni pipe in a blackwater system.

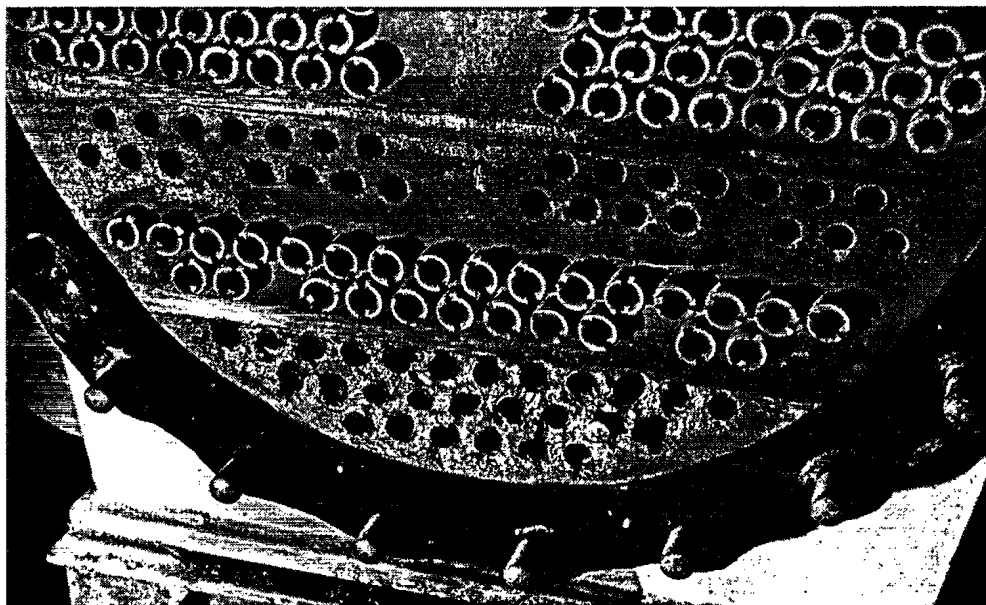
Heat exchangers using sea water as a coolant have been used extensively in ships of the Canadian Forces. In the past, most of these heat exchangers have been fabricated with 90/10 copper nickel tubes and Naval brass (UNS C46400) tube plates. These systems have provided excellent service as long as the alloys have been protected against corrosion by the use of sacrificial steel anodes. When these anodes have not been properly utilized, failure of the 90/10 tubes and erosion corrosion of the Naval brass tube plates has occurred (Figure 2).

Figure 2. Erosion corrosion of 90/10 Cu-Ni tubes and Naval brass tube plate (assisted by dezincification of the tube plate).

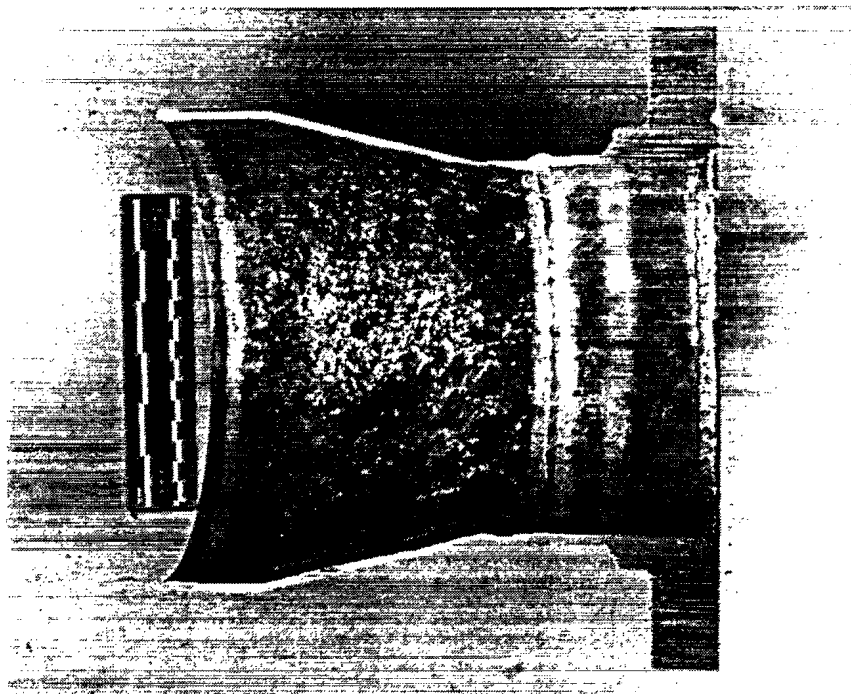
Figure 4. Cross-section of transition piece showing erosion corrosion downstream from a circumferential weld.

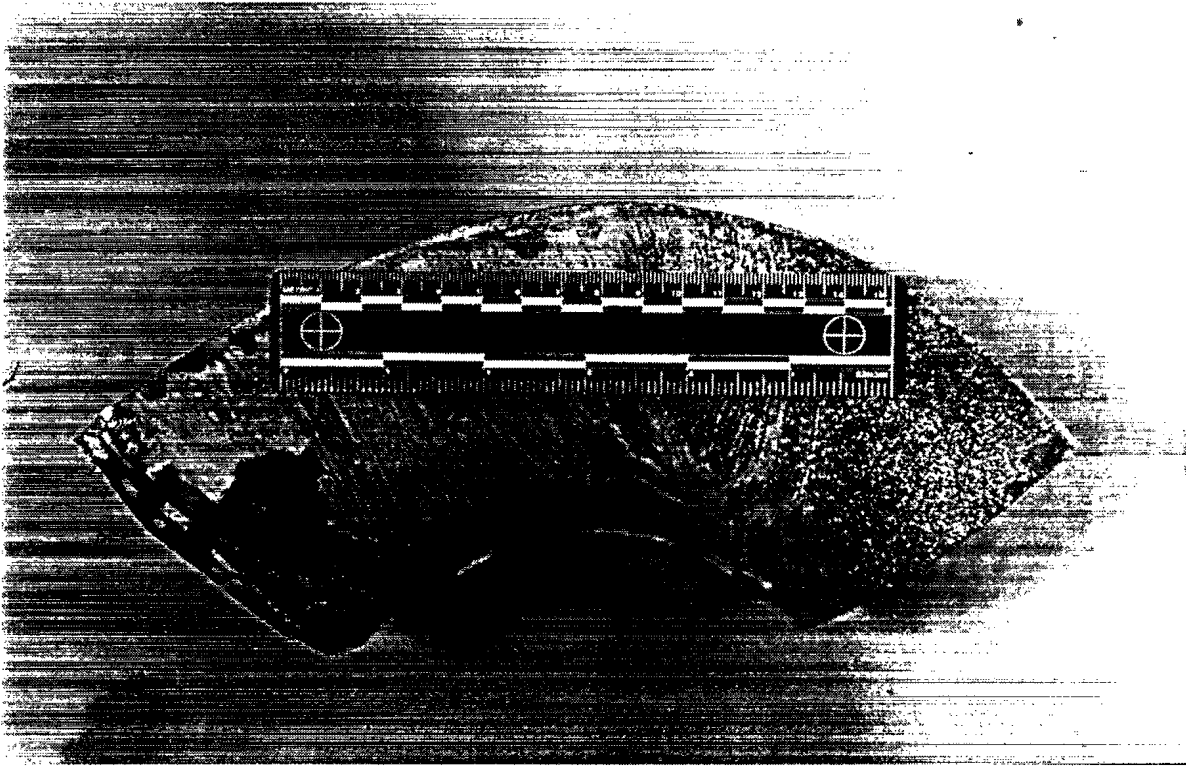
This piping system was also found to contain a number of seamed elbows with a very tight radius of curvature (Figure 5). The welds in these elbows which ran parallel to the direction of flow had been carefully ground out, but the circumferential welds, which connected the elbows to the rest of the piping system, protruded into the flow stream (Figure 6). The resulting turbulence gave rise to erosion corrosion (Figure 7) similar to that observed in the transition section. Also like the transition section, the material in the bend had a lower iron content (1.10%) than that recommended for sea water service. The turbulence cause by the tight radius led to impingement attack in the classic "horse walking upstream" pattern¹³ (Figure 8). Prevention of the corrosion problems observed in the bends could be achieved by tighter quality control of the welding, by using an alloy with a higher iron content and by using bends with larger radii. LaQue¹⁴ has recommended bends with a minimum radius of three pipe diameters. This is the minimum radius specified in the piping standard that is normally applicable to Canadian naval vessels. However, in a few cases, exemptions were granted in order to solve some pipe routing problems. Similarly, the welding specification allowed a maximum root concavity of 1.5 mm. This specification could be achieved during the fabrication of individual modules but proved difficult to meet in some of the field welds that tied the modules together. These welds were located in areas that made electrode manipulation awkward and efficient argon purging difficult, with excessive weld penetration as a result. In the future, the selection of locations for field tie-ins should be made with accessibility for welding and the sea water flow conditions in mind.

Figure 5. Seamed elbow with tight radius of curvature. This elbow was bisected in the direction of flow prior to this photograph.

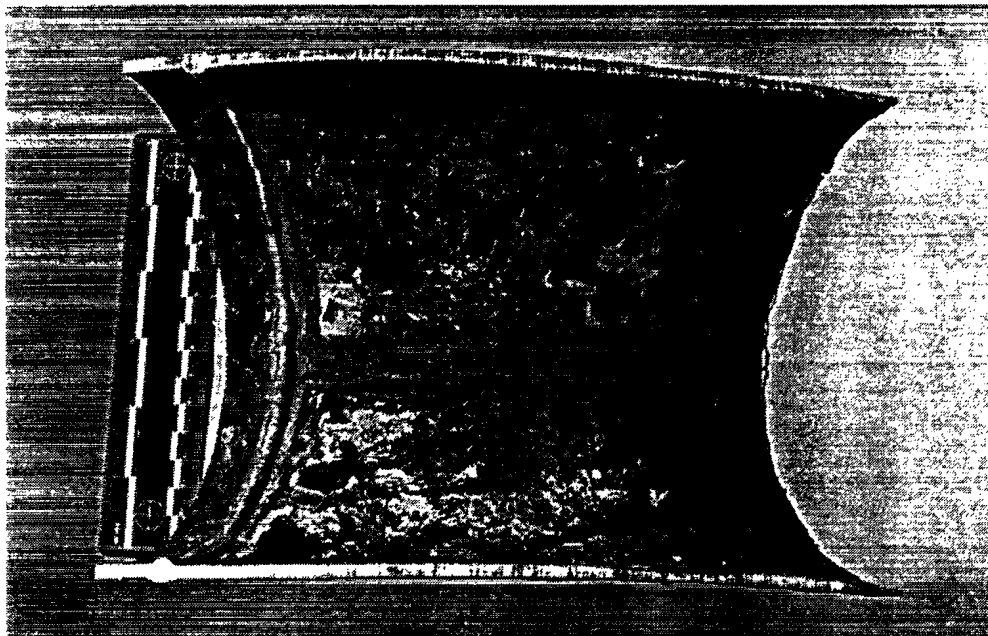
Figure 6. Seamed elbow with weld in direction of flow ground out. Circumferential weld protrudes into flow stream.

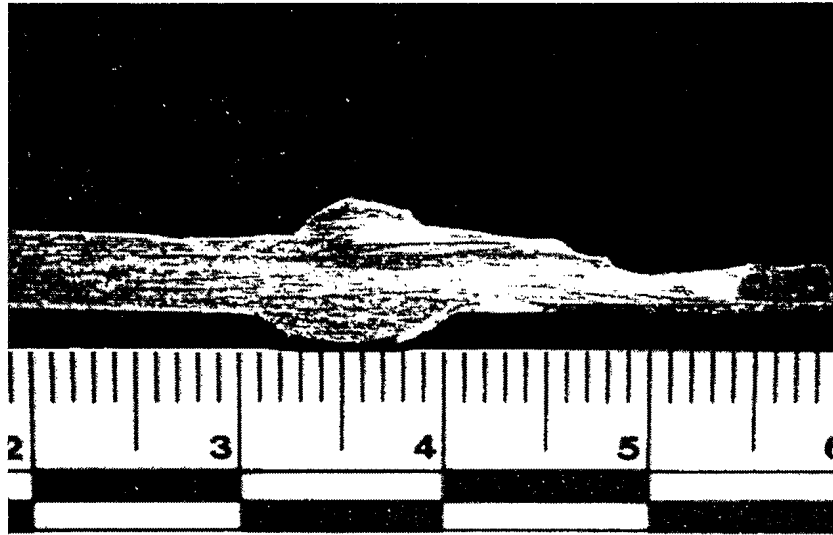
Figure 7. Cross-section showing erosion corrosion downstream from a weld.

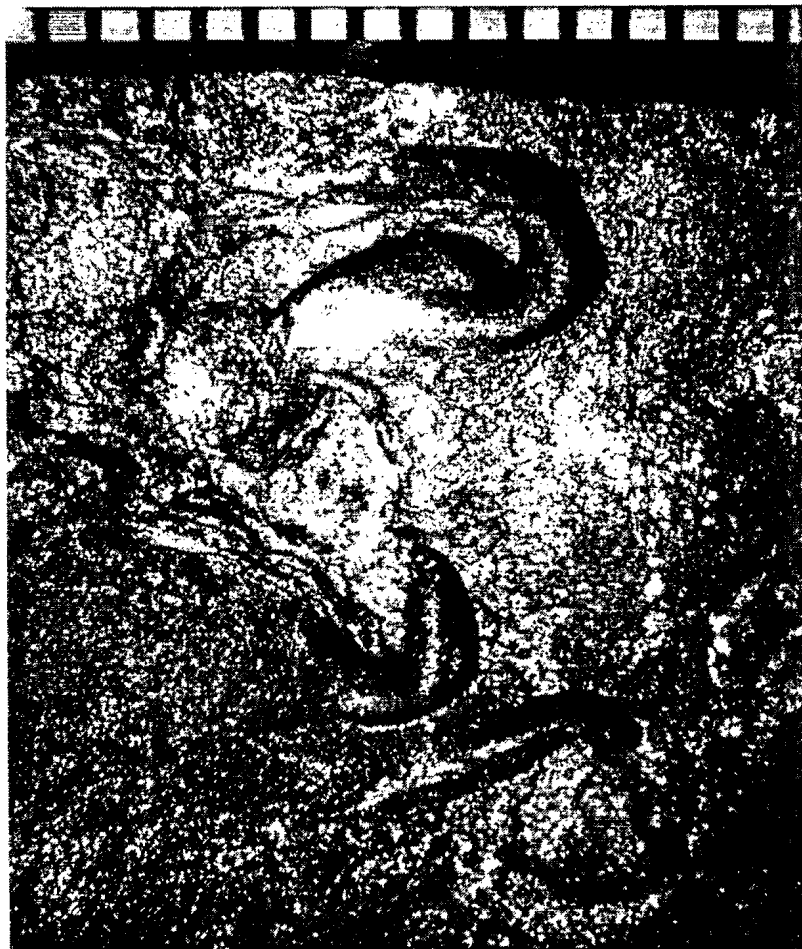
Figure 8. Horseshoe pattern typical of impingement corrosion in a tight bend.

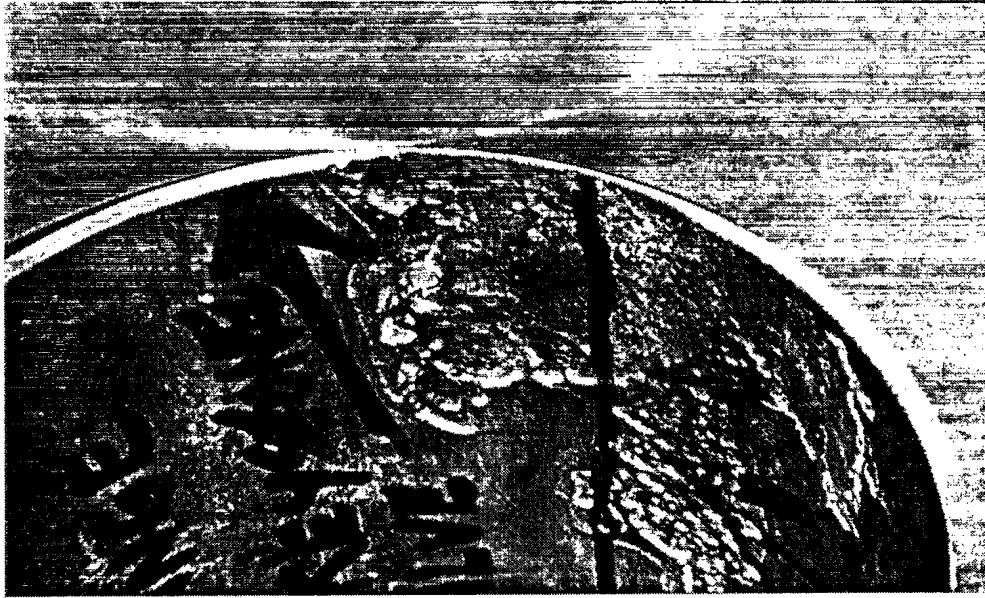
In an effort to reduce staffing requirements, remotely operated flow control systems have been incorporated into new or updated sea water systems. Complicated arrangements of cross-over pipes and valves, intended to provide redundant flow paths to important pieces of equipment, have also been utilized. These factors have led to some unusual flow conditions within the piping systems. For example, a section of firemain failed in a cross-over pipe that was nominally upstream from a butterfly valve. The erosion corrosion was very localized (Figure 9), suggesting that the valve had been left slightly open, creating an eddy in the "upstream" pipe.

Figure 9. Erosion corrosion near a cross-over valve.

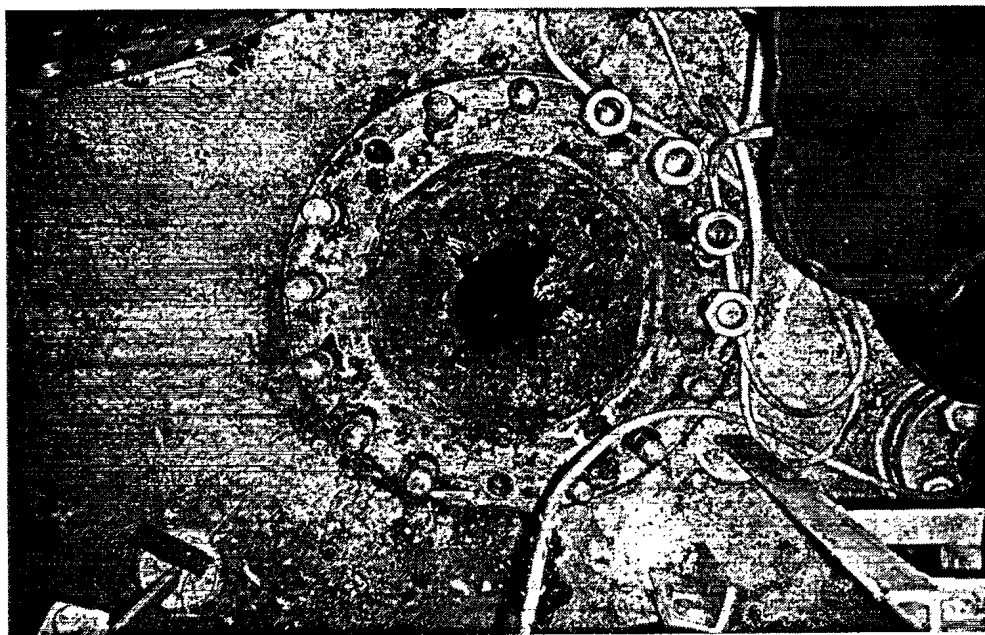
Figure 10. Firemain fouled with marine organisms.

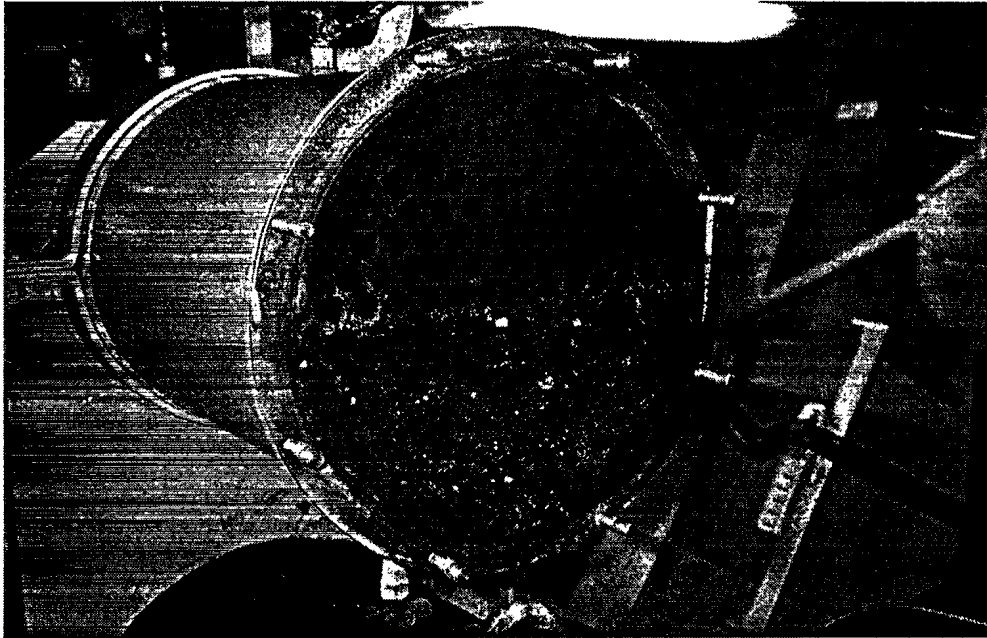
Figure 11. Extent of blockage in a chiller 3 months after cleaning.

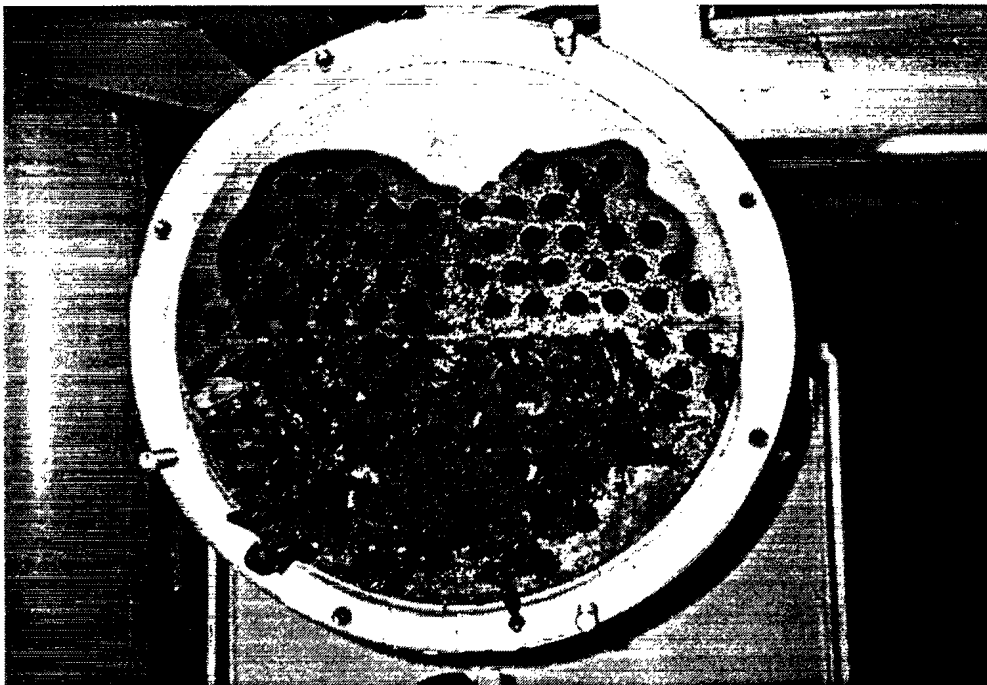
The redundant sea water flow paths mentioned earlier, along with a new philosophy of supplying water on demand, have given rise to another problem that had only been observed on a few isolated occasions in the past. The gentle flow of sea water in some pipe runs has provided an ideal environment for the attachment of marine organisms. As a result, these pipes have become heavily fouled (Figure 10). For a number of reasons, including visits to fresh water ports, the colonies can die off. When this happens, particularly in the case of hydroid colonies, parts of the colonies break off in chunks and become lodged in the orifices in the tube plates of heat exchangers. Figure 11 shows the extent of the blockage that occurred on the supply side of a heat exchanger just three months after it had been completely cleaned. The mass of dead hydroids provides an ideal home for other organisms and thriving colonies of mussels and barnacles have been observed (Figure 12).

Figure 12. Mussels and other marine organisms blocking a chiller that had been in service without cleaning longer than the chiller shown in Figure 11.

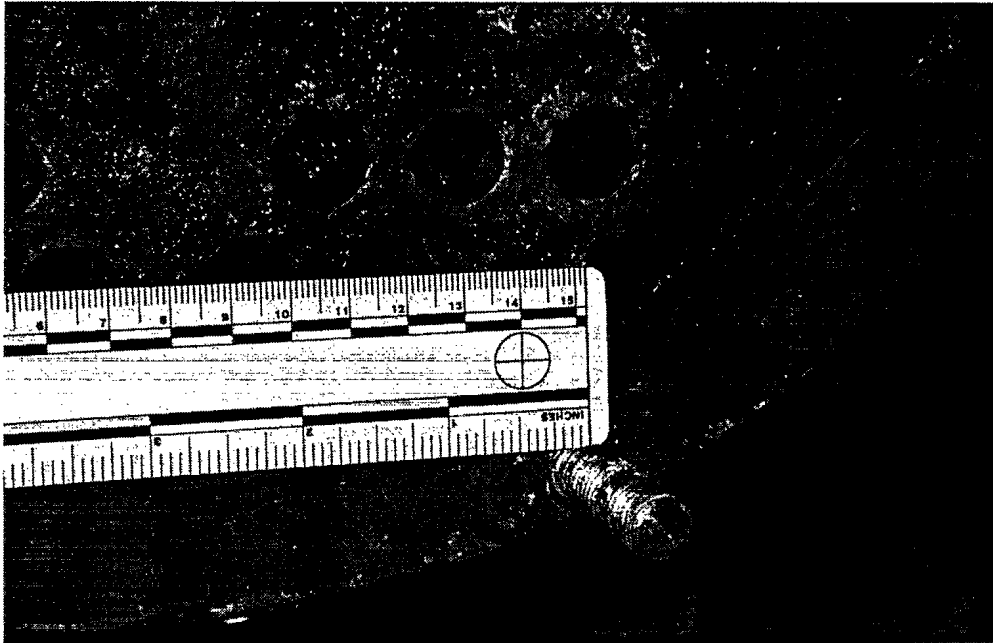
With so many tubes blocked, the flow through the remaining tubes occurred at a higher velocity than that assumed in the original design. As a result, erosion corrosion of the tube ends has occurred (Figure 13). The altered flow patterns have also caused erosion of the divider plate (Figure 14). The installation of sacrificial steel anodes in the end bells would increase the resistance to erosion corrosion. Ship staff and the Fleet Maintenance Facilities have been installing these anodes as opportunities arise. While anodes will help to reduce the extent of erosion corrosion, elimination of the problem will require removal of the marine growth throughout the ship. Under current operating conditions, this will be very difficult to achieve.

Figure 13. Erosion corrosion of 90/10 Cu-Ni tube ends resulting from blockage.

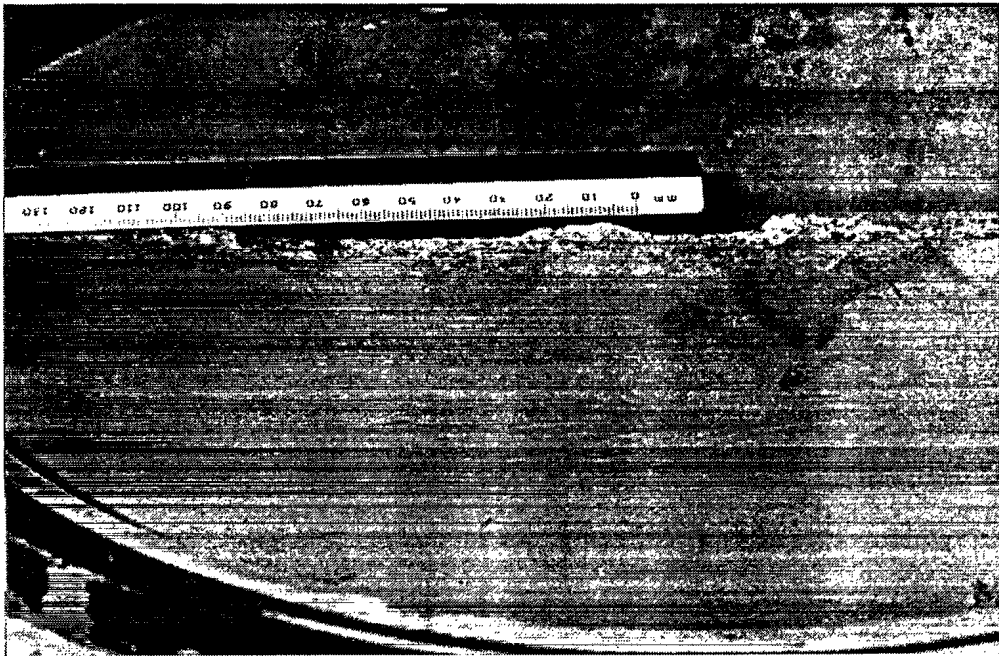
Figure 14. Erosion corrosion of divider plate resulting from blockage.

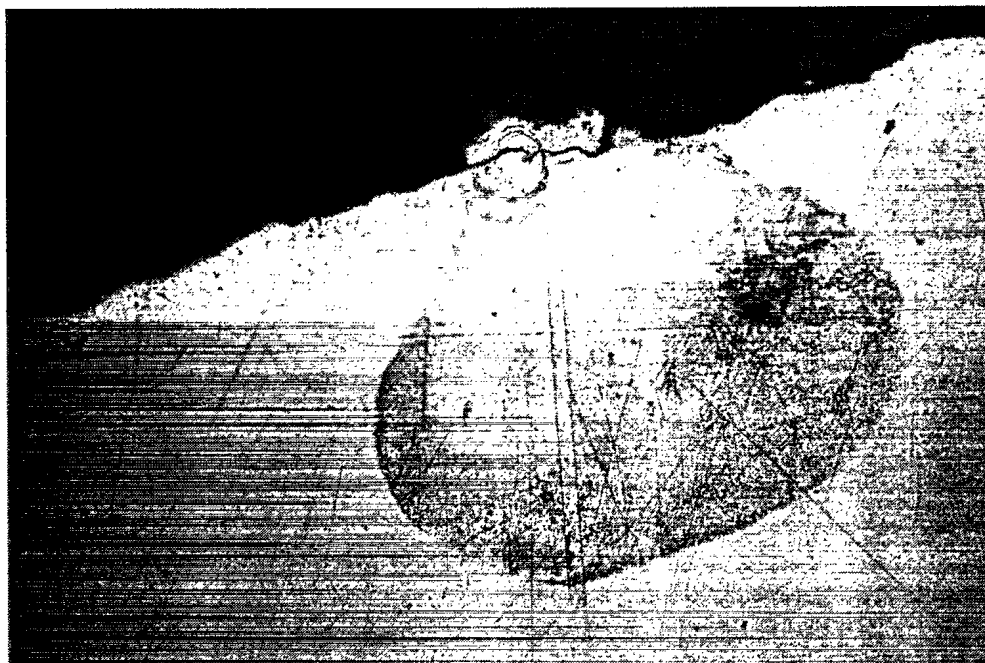
The precise mechanism of denickelification is still a matter of some controversy. However, the end result is a pit with associated deposits of copper. Some of this copper can be found in locations downstream from the original pit (Figure 16). Denickelification has also been observed under conditions that are less severe than those known to cause "hot-spot" corrosion. For example, a leak developed in a hydraulic oil cooler after it had been in operation for 15 months. Examination of the failed 70/30 copper-nickel tube (Figure 17) revealed a deep pit that had been initiated on the sea water side. There were several other pits containing deposits of copper. The hydraulic oil normally bypasses this cooler until the oil reaches a temperature of 30°C, so the temperature of the oil entering the cooler is normally between 30° and 40°C. If the temperature reaches 65°C, an alarm is activated. Sea water flows constantly through the cooler while the ship is at sea, but flow to the cooler is shut down while the ship is in port, leaving the cooler full of stagnant sea water. Because this tube had been cleaned prior to delivery to the Dockyard Laboratory, it was not possible to determine the exact sequence of events that led to the perforation. Almost certainly, the pit was initiated during a shut-down period as a result of contact with sulfide-polluted, stagnant sea water. It could not be determined whether the ensuing corrosion occurred only during shut-downs or also continued under a deposit which shielded the pit from flowing sea water while the ship was at sea.

Figure 16. Copper particle downstream from a pit. An alcohol stain is also visible. 450x.

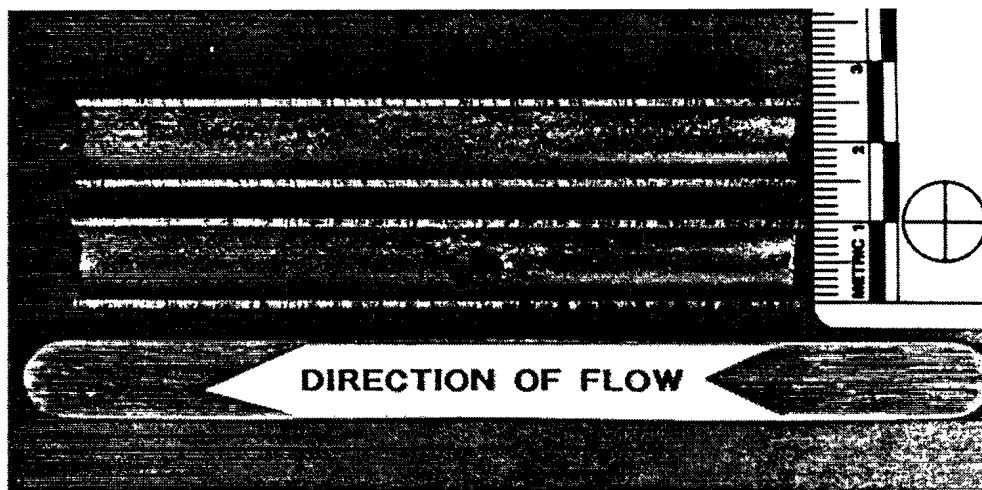
Figure 17. Pit initiated on the sea water side of a 70/30 tube in a hydraulic oil cooler.
