## Investigation of Cracked Propeller Blades on an Icebreaker

by L.N. Pussegoda and L. Malik

**8th CF/CRAD Meeting on Naval  
Applications of Materials Technology**

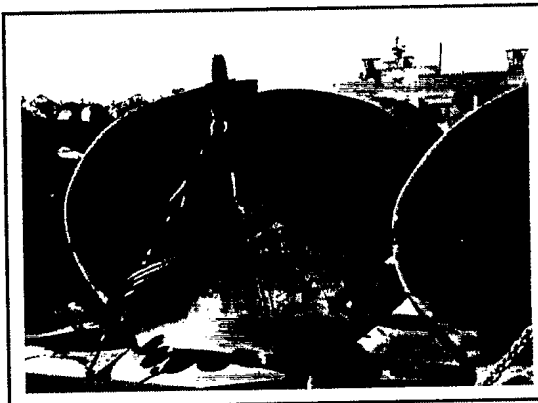
- **A Broken Blade  
(two out of four)**
- CP Port Propeller  
- damaged,
- Starboard  
- no damage,
- Material – Cunial  
(Ni-Ai-Bronze)

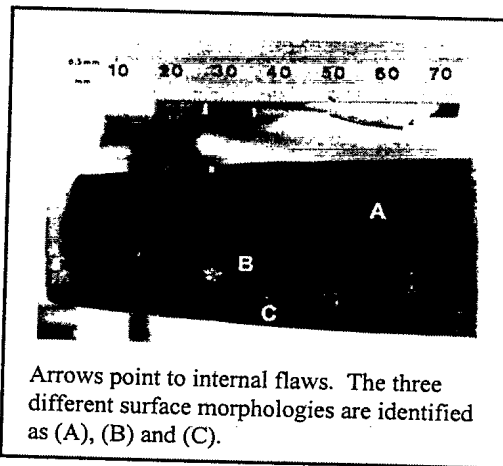
Local fracture propagated in stages.

Arrows point to internal flaws. The three different surface morphologies are identified as (A), (B) and (C).

- Fracture surface morphology indicates crack propagation in buildup areas caused by discrete loading events
- Arrest of cracks in this region; a) unloading, b) encountering higher toughness region (refined microstructure in the buildup region), c) at a boundary of a weld pass, and d) encountering an internal flaw with different orientation
