The effects of decaying marine organisms on the corrosion of copper-nickel alloys in sea water

D. R. Lenard and R. R. Welland

Defence Research Establishment Atlantic Dockyard Laboratory (Pacific)

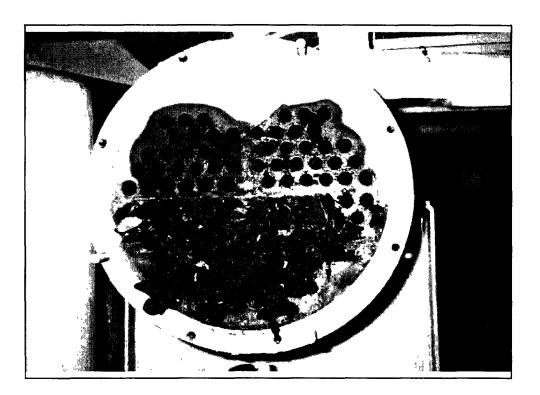
• Blockage on the supply side of a chiller 3 months after a previous cleaning. Most of the material consisted of the remnants of mussels and hydroids that were killed by exposure to fresh water during a visit to Portland, OR. The dead shells broke away from other parts of the system and were trapped at the tube plate. However, this material formed a base for new growth and live four-day old mussels were found in the debris in mid-December, well outside their normal attachment season.

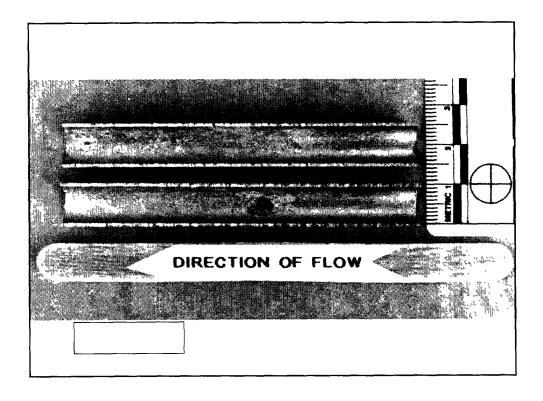
PITTING IN A HYDRAULIC OIL COOLER

- · Leak developed after 15 months
- Constant flow of sea water through cooler at sea.
- Flow shut off in port, leaving cooler full of stagnant sea water.
- Temperature of oil entering cooler normally 30 40 Celsius
- If temperature reaches 65 C, alarm activated: never happened.

- Pitting may be a continuing problem in some systems on HALIFAX-class ships.
- TO AVOID PROBLEMS IN FUTURE SHIP CONSTRUCTION:
 - Maintain flow rate above 0.9 m/sec (macro-fouling organisms have difficulty attaching).
 - Flush, drain and blow dry systems during periods of shutdown.
