Title: Voltage Noise Measurements on Sealed Lead Acid Batteries.

CRAD HQ contractor/DRDA paper  
Submitted to and Published in  
Journal of Power Sources  
v 27 n 2 p 177-186  
Aug 1989

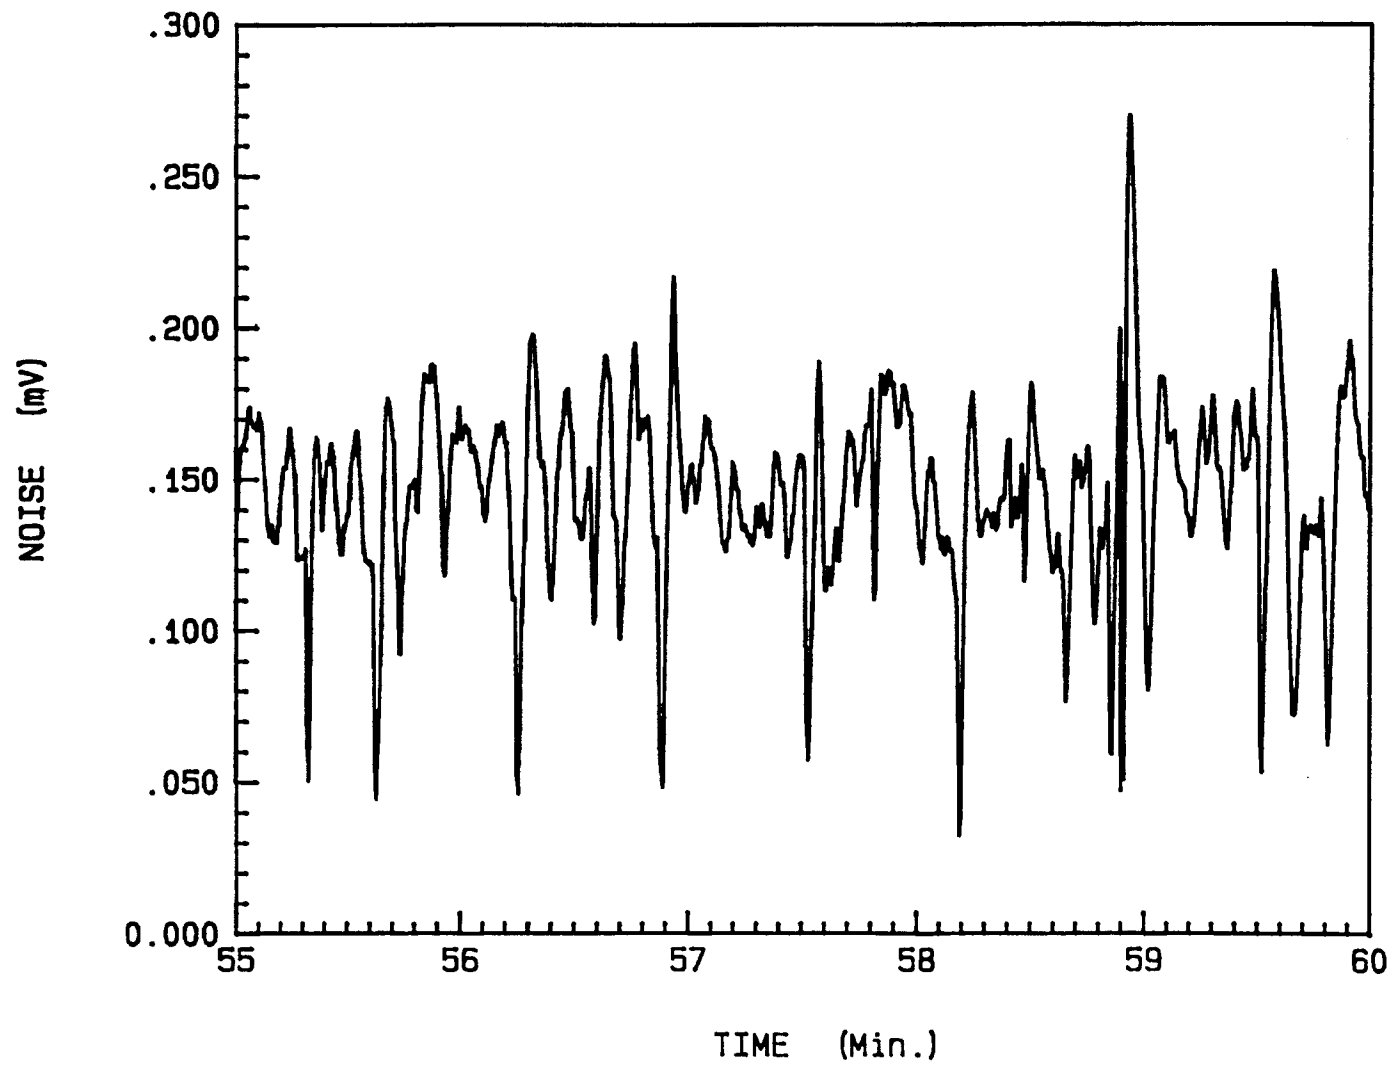
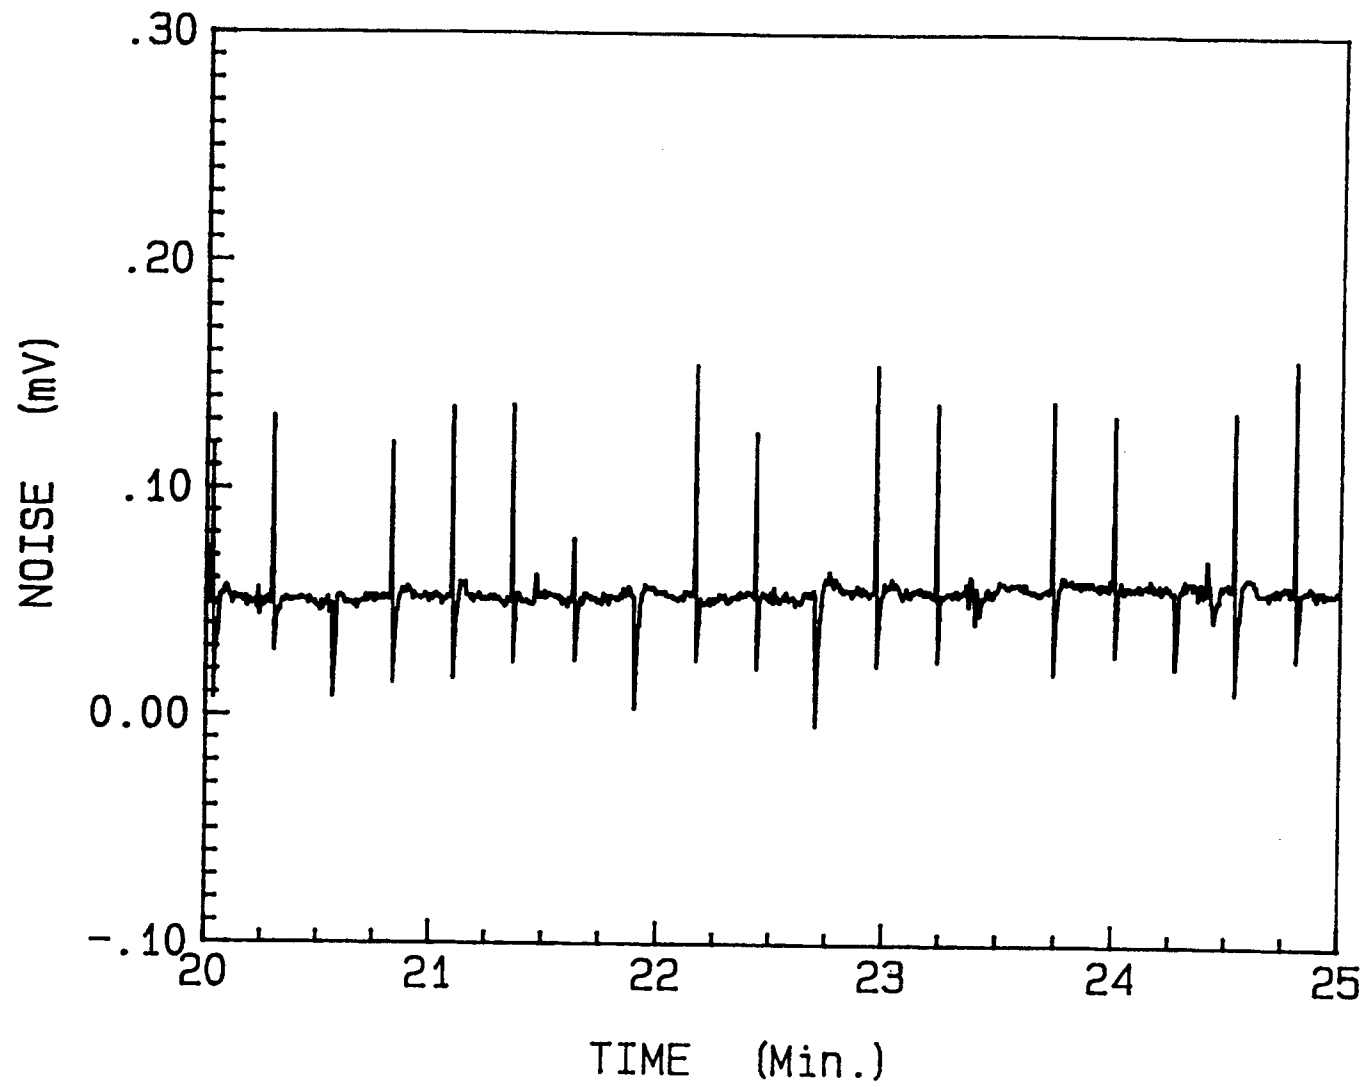
- Fig. 4 Noise patterns of a noisy Gates "J" sealed lead acid cell  
while on charge at 0.5A and observed at different locations:  
a) total cell; b) positive electrode; c) negative electrode;
