Materials Solutions to the Aging Aircraft Problem

by K.I. McRae

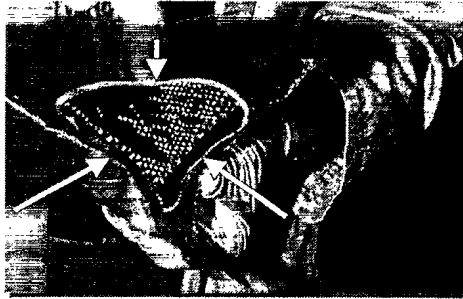
B-staged Patch Ready for Installation

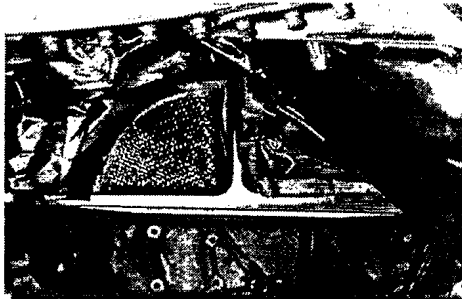
Placement of Patch in X-19 Corner

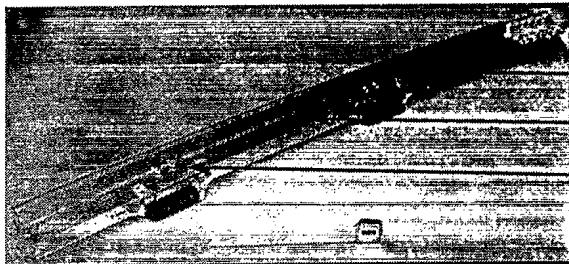
RRA - CC130 sloping longeron

Tests were conducted on service-exposed longeron using Zimac hot bonder and heater cells/blankets, heat was applied directly to the longeron in localized regions.

Heat-affected zone
Heat-treated zone
Heat-affected zone

Stress corrosion cracking occurring on the sloping longeron of the CC130 Hercules

- (1) Use RRA on Al 7075-T6 to maintain the high strength of the T6 temper while gaining the corrosion resistance of the T73 temper
- (2) Adapt the parameters of the RRA process to an in-situ treatment

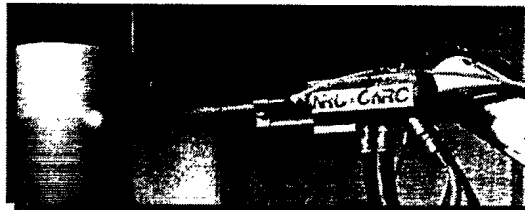
Hard Chromium Alternatives

- US DoD and DND joint program to replace hard chrome on landing gears
- Elimination of Cr^{6+} from the environment
- WC-Co and WC-CoCr coatings applied by HVOF spraying
- Currently limited to landing gear applications but can extend to actuators and engine components

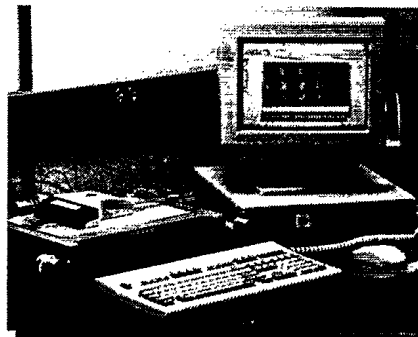
Edge-of-Light for Corrosion Detection

This is a scanner based optical inspection system which finds pillowing caused by corrosion in riveted joints.

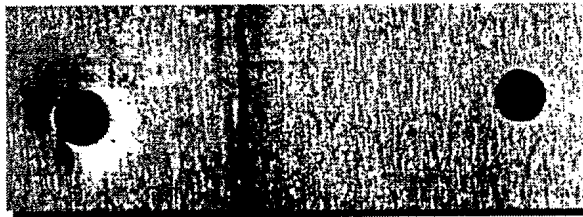
Edge of Light NDI

Crack
Detection

Detection of
Cold-working

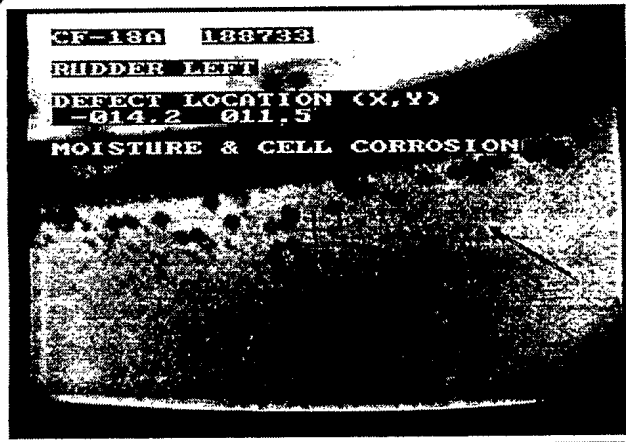
CF-18 Rudder Water Ingress

N-rays are attenuated by light elements such as hydrogen, hydrated materials or hydroxides in corrosion products.

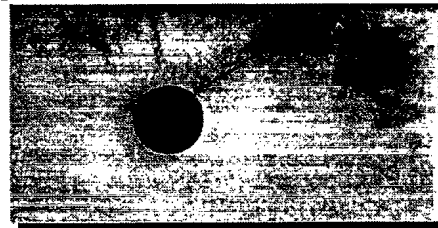
Boeing 727 Specimen Teardown

X-ray images

- Upper rivet row inner skin, faying surface.
- Dark areas contain ~10% thickness loss maximum.
- Cracks in the areas adjacent to maximum corrosion pillowing.
