Contamination and Decontamination of a Light Armoured Vehicle

Work performed under the Swedish-Canadian accord

TECHNICAL MEMORANDUM

DRDC Ottawa TM 2002-107

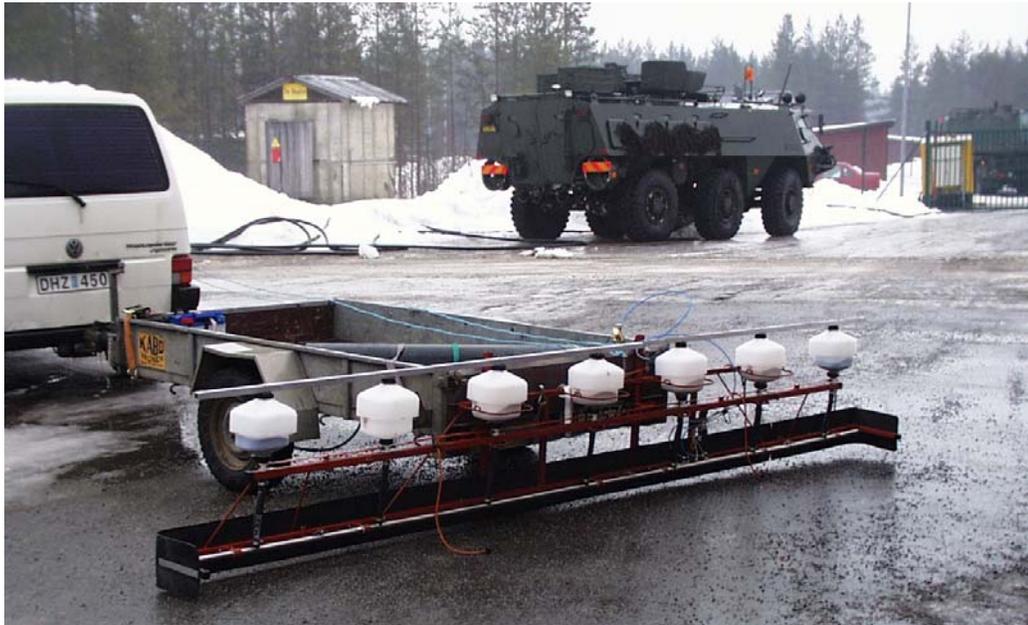
Figure 1. The vehicle used for spreading the Na-24 on the Swedish track. The seven plastic containers are each filled with an equal quantity of sand and radioactive sodium.

These experiments took place in the NBC test facility (NBC-Bana) of the Swedish NBC Defence Centre (Totalförsvarets Skyddscentrum) in Umeå, Sweden. Sodium-24 in the form of powdered sodium silicate was mixed with sand and loaded into the seven containers in the trailer depicted in Figure 1. The driver of the white van pulling the trailer can activate a switch that empties these containers slowly through the vertical tubes shown below the plastic containers. The tubes are oscillated left and right to produce a more uniform deposition pattern on the ground. The radioactive material was set down on a 4.2-metre wide, 500-metre circumference track. The material was released at a constant rate, so variations in road contamination were achieved by driving the van at different speeds over different segments of the track. Road conditions were wet and icy, and the surface was roughed up by a snowplow prior to spreading of the material. Weather conditions during the trials consisted of light rain.

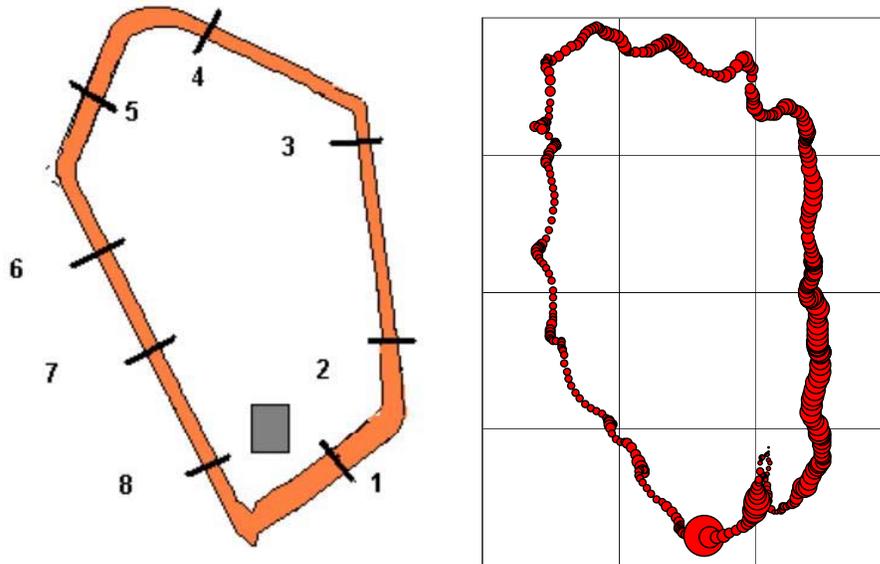
Figure 2. (Left) A sketch-map of the contaminated road at the test facility of the National NBC Defence Centre in Umeå. The grey rectangle at the bottom of the figure indicates the main building of the school, which was where the measurements and decontaminations took place. The numbered lines indicate the presence of stations where road contamination was measured. The circumference of the track is approximately 500 m, and its width is 4.2 m. (Right) A “bubble plot” of the dose rates at 1 m above the track, measured approximately 2 hours before the experiment commenced. The positions of the bubbles are based on the GPS co-ordinates at which the measurements were taken; the areas of the bubbles are proportional to the dose rates at those points. For reference, the largest bubble (at the bottom of the plot) corresponds to a dose rate of 23 $\mu\text{Sv/h}$. The grid squares in this plot are 50 m on a side.

Figure 2 shows two maps of the road. The first is a sketch; the second is a “bubble plot” showing the dose rates at 1 m above the ground around the track, as measured by a BTI Microspec-3 mapping gamma-ray spectrometer [4]. The areas of the bubbles are proportional to the dose rates. The dose rates in turn are proportional to the contamination level on the road. Microshield [5] calculations demonstrate that for a

4.2-metre wide track, 1 MBq/m^2 of Na-24 contamination produces a 1-metre dose rate of 4.5 $\mu\text{Sv/h}$. Since dose rates over the track averaged approximately 2.5 $\mu\text{Sv/h}$, one could conclude that the average contamination level on the road was about 0.56 MBq/m^2 . This in turn implies that the total contamination on the track would only have been about 1.2 GBq. Bowls with a size of 0.015 m^2 that were placed on the road during the spreading of the activity contained even less activity (on average 0.23 MBq/m^2 , implying 0.5 GBq total activity on the track). Since we know that the amount of activity in the seven plastic containers of the spreading device was around 9 GBq, one could assume that a large portion of that activity never left the containers. The weather conditions of the day were moist and this affected the Na-24. Sodium silicate has a strong tendency to take up water and adhere to other materials. It was obvious that it stuck to the aluminum vessel used for the transport of the radioactive material. It was likewise apparent that the two outermost containers of the spreading vehicle were far from empty, and it appears conceivable that the Na-24 also stuck to the plastic walls of the spreading device and to the interior of the outlet system. The chemical properties of sodium silicate could explain the low activity in the bowls since it appears likely that the sodium silicate was not homogeneously distributed on the road. In addition, it must be assumed that a substantial amount of radioactive material was washed off of the road because of the rain. A more detailed examination of the road conditions will be conducted in a future report.

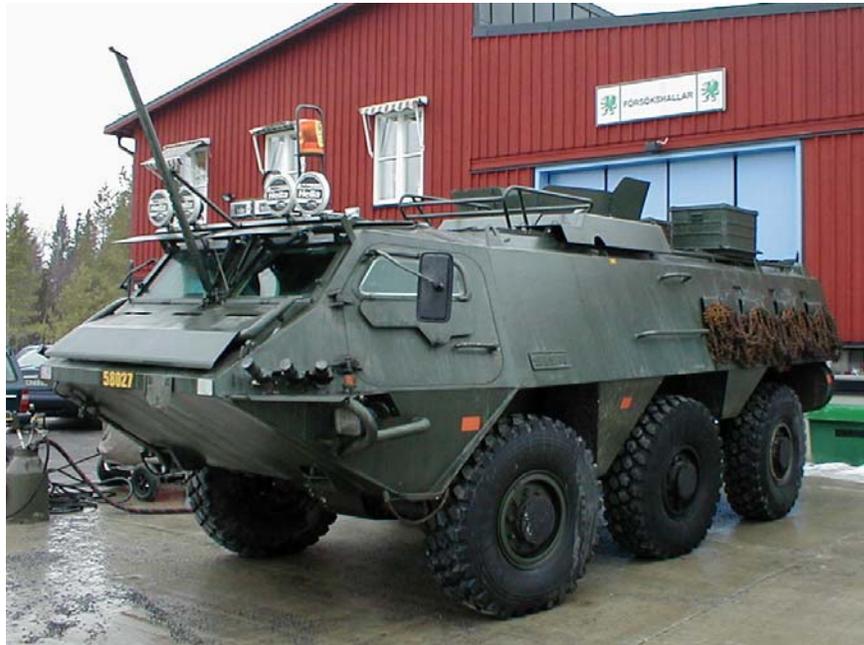
Figure 3. *The SISU XA-180 Light Armoured Vehicle.*

The test vehicle for the trials was a SISU XA-180 Light Armoured Vehicle, pictured in Figure 3. The XA-180 drove around the contaminated track 10 times, and then returned to the measurement area. The contamination pattern was then characterized with the ABP-100 alpha-beta probe [6] and with swipes. A Swedish team without previous experience of decontaminating the XA-180 then decontaminated the vehicle with a high-pressure water spray. This is the same system developed by DRDC Suffield, but without the CASCAD decontaminant foam [7]. Following this procedure, the remaining contamination on the vehicle was re-measured. The XA-180 was then driven out onto the track again for 10 laps, before returning to the measurement area. As before, the contamination pattern was characterized. A team from VLN Advanced Technologies Inc. then attempted to decontaminate the vehicle with their forced pulsed water jet system. The remaining contamination on the vehicle was again re-measured. The VLN water jet system is capable of running at extremely high pressures, however for this work pressures were constrained so that the paint on the XA-180 would not be removed. That being said, paint was removed from the vehicle wherever it was the least bit loose.

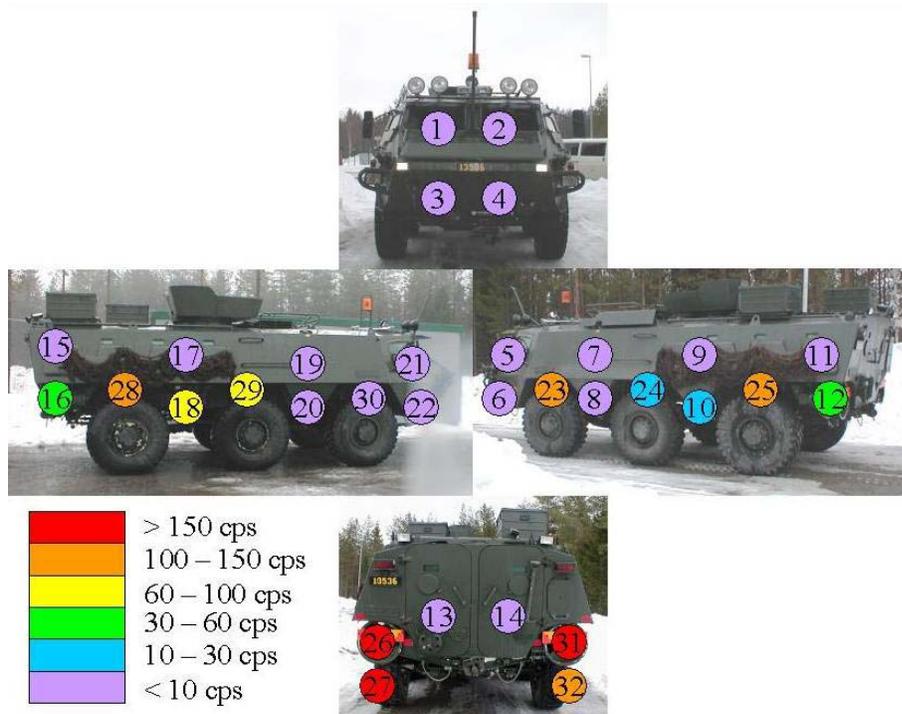
Figure 4. Contamination levels on the XA-180, as measured with the ABP-100 alpha-beta probe. Each circle denotes a measurement location, colour-coded according to the magnitude of the measurement (actually the average of the two contamination measurements). Each bubble contains the location number by which the locations are identified in this document.

The most complete characterization of the vehicle contamination was performed with an ABP-100 alpha-beta probe. While such measurements are often not the most sensitive assay of contamination, they have the advantages of being field-expedient and of measuring total contamination, both removable and fixed. These measurements¹ are given in Table 1 for both contamination trials (after each 10-lap circuit). The two sets of measurements bear some resemblance to one another, especially in the general trends described below. However, a comparison also reveals that individual contamination measurements at a given position on the vehicle are not reproducible for the two experimental trials. These pairs of measurements can vary by up to a factor of five. The average values over the two trials are also shown superposed on pictures of the vehicle in Figure 4. The circles in that figure are colour-coded according to the count rate, and the numbers in the circles correspond to the location numbers in Table 1.

The contamination levels on the vehicle follow a relatively predictable pattern. Namely, very little contamination collects on the front or rear of the vehicle, or anywhere on the upper half of the vehicle. On the other hand, significant contamination can accumulate on the lower halves of the vehicle sides, especially in the wheel wells. It is worth noting that positions 26, 27, 31, and 32 are on or around the two propellers at the rear of this amphibious vehicle. However, because of the vehicle design, this part of the vehicle is essentially part of the wheel wells for the rearmost wheels. These are the most highly contaminated surfaces on the XA-180. It is quite reasonable that the wheel wells are contaminated to the highest level, since the tires are responsible for “kicking up” the contamination. However, it is also worth noting how little contamination ends up in some of the other areas under the wet conditions prevailing during these trials.

Table 1. Count rates on the ABP-100 alpha-beta probe for various locations on the XA-180. A contamination level of 1 Bq/cm² would produce a count rate of approximately 30 cps. "BDL" stands for "Below Detectable Limits". Locations are identified in **Figure 4**.

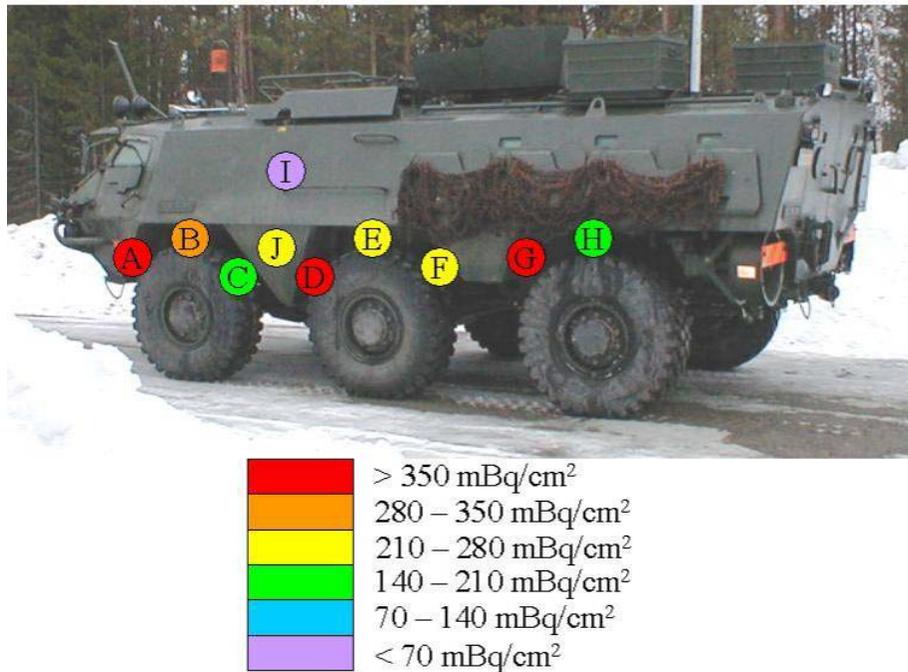
Figure 5. Contamination levels on the XA-180, based on swipe measurements. Locations A-H are located in the wheel wells of the vehicle. The letters denoting the position are used throughout this document.

Contamination levels on the XA-180 were also assessed by swipe tests on vehicle surfaces. Swipes were measured in a Liquid Scintillation Counter (LSC). Such techniques are generally very sensitive assays of removable contamination, although obviously they can say nothing about the level of fixed contamination. Swipes were taken primarily in the wheel wells of the XA-180, where probe measurements are more difficult, due to the possibility of probe contamination. The two sets of measurements are shown in Table 2. As was noted above, general trends in contamination levels are consistent in the two data sets (e.g. location I is always less contaminated than any other surfaces), although the contamination levels at a given location are far from reproducible. In fact, these data are less reproducible than the probe measurements. The average measurements for each location are superposed on a picture of the XA-180 in Figure 5. As above, the circles are colour-coded according to the measurements, and the letters in the circles correspond to the letters in Table 2. Values in the table are shown as “BDL” if they are consistent with zero given their uncertainties. The uncertainties are the sum in quadrature of a 10% uncertainty on the background-subtracted value and an 8.8% uncertainty on the unsubtracted quantity (this latter is an observed variation in several measurements of a control sample). These uncertainty estimates are felt to be conservative.

Because swipes were taken largely in similar areas, there are few general conclusions that can be drawn about vehicular contamination. However, one can easily see that the swipe data support the earlier observation that contamination did not collect on the upper half of this vehicle. No differentiation can be made, however, between the data collected from the other nine locations.
