DCIEM No. 97-TM-12

**DETECTING CRACKS UNDER  
FERROUS FASTENERS  
USING THE NORTEC-30  
EDDYSCAN FASTENER HOLE  
INSPECTION INSTRUMENT**

R.W. Nolan  
K.I. McRae

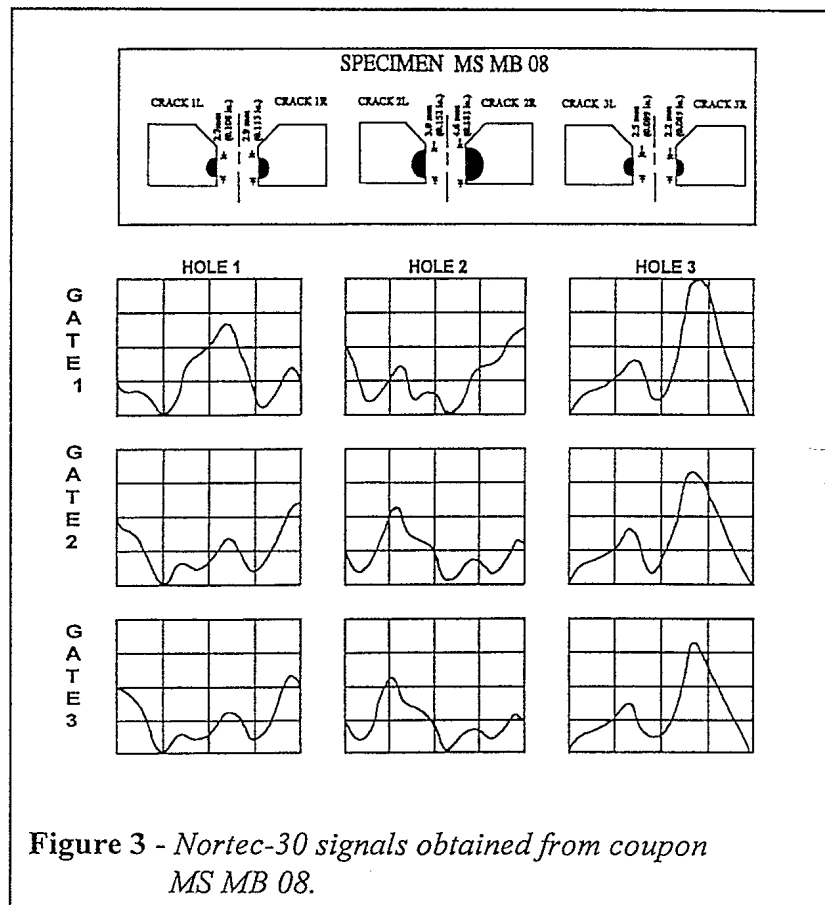
Figure 3 - Nortec-30 signals obtained from coupon MS MB 08.

Figure 3 contains a schematic diagram showing the dimensions of the cracks in each of three holes in coupon MS MB 08. Tracings of the signal obtained from each hole in the specimen at each of three different Nortec-30 gate settings (depths) are illustrated underneath each schematic. The trace on each of the grids (three per hole) represents signal strength (0-100%) versus angular position around the circumference of the hole, with the origin being 12 o'clock, the first vertical line 3 o'clock, etc. It can be seen that although the cracks on opposite sides of a given hole are approximately the same size, a strong signal was normally obtained in only one location and that this location was most often not in the "correct" orientation. In this case, the weakest signal was obtained from the hole with the largest flaw and vice versa.

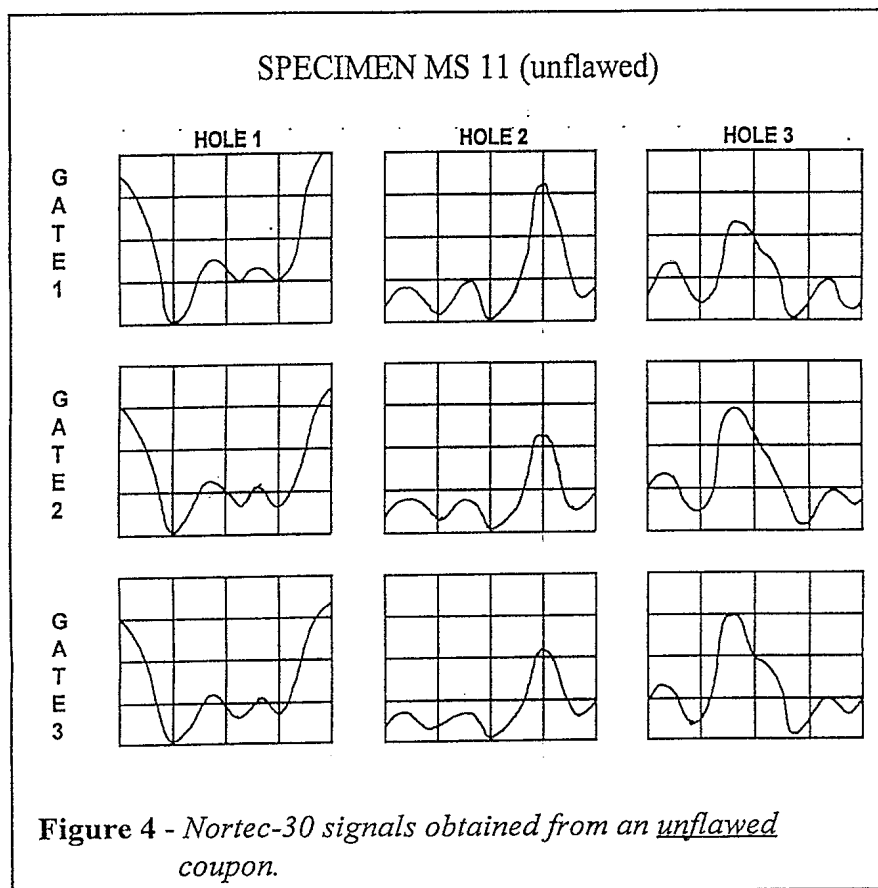
Figure 4 shows the Nortec-30 results obtained from each of three unflawed holes in coupon MS 11. All instrument settings were the same as for Fig. 3. It can be seen that cracks were indicated in each hole and that in most cases the signals obtained were stronger than those from the flawed specimen.

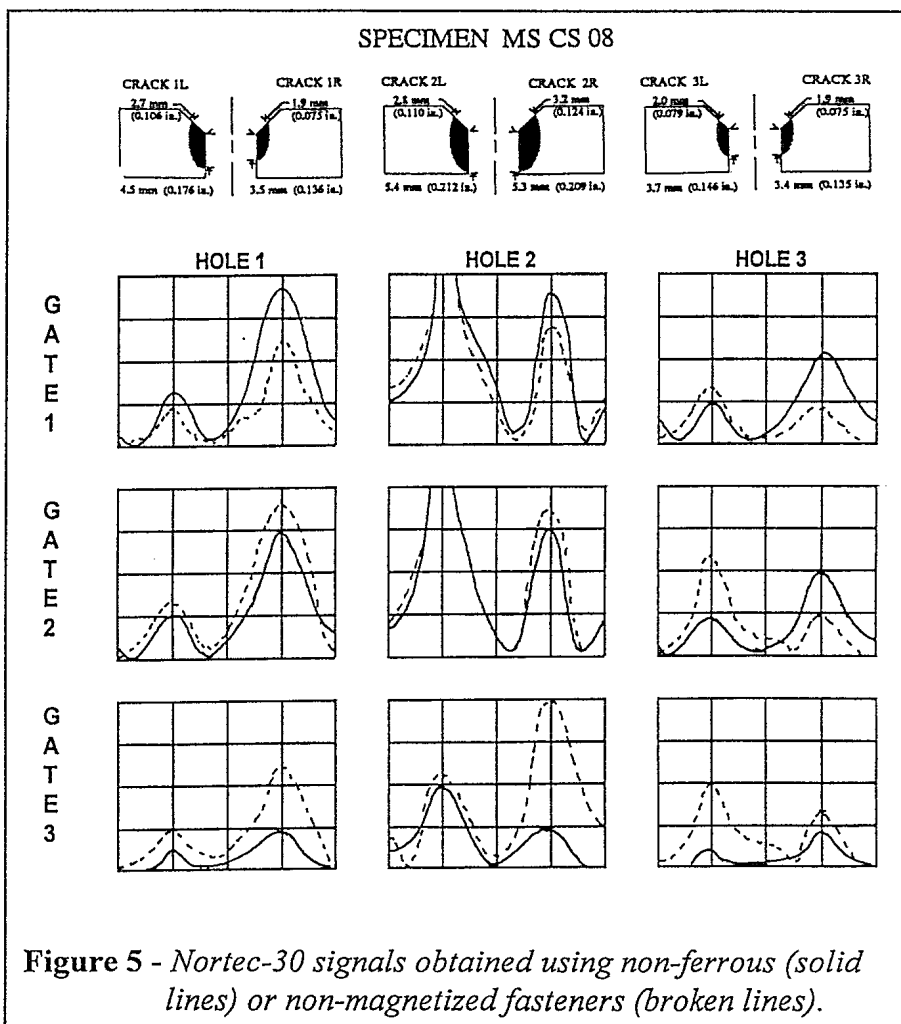
The above experiment was repeated with the same flawed and unflawed test coupons but using titanium rather than ferrous fasteners. No defects were found in the unflawed sample. The signals obtained from the flawed coupon (MS CS 08) are illustrated in Fig 5 and were as expected. They show that the defects were located as indicated in Ref 1 (at 3 and 9 o'clock) and that signal strength was proportional to the relative size of the cracks.
