Microbiological Contamination of Shipboard Fuel Systems,  
Causes-Consequences-Control

R.D. Haggett

Defence Research Establishment Atlantic  
Dockyard Laboratory, FMO Halifax, N.S. Canada, B3K 2X0

Presented at the 2nd Canadian Forces/CRAD Meeting on Naval Applications of Materials Technology, 2-4 May, 1995, Halifax, NS.

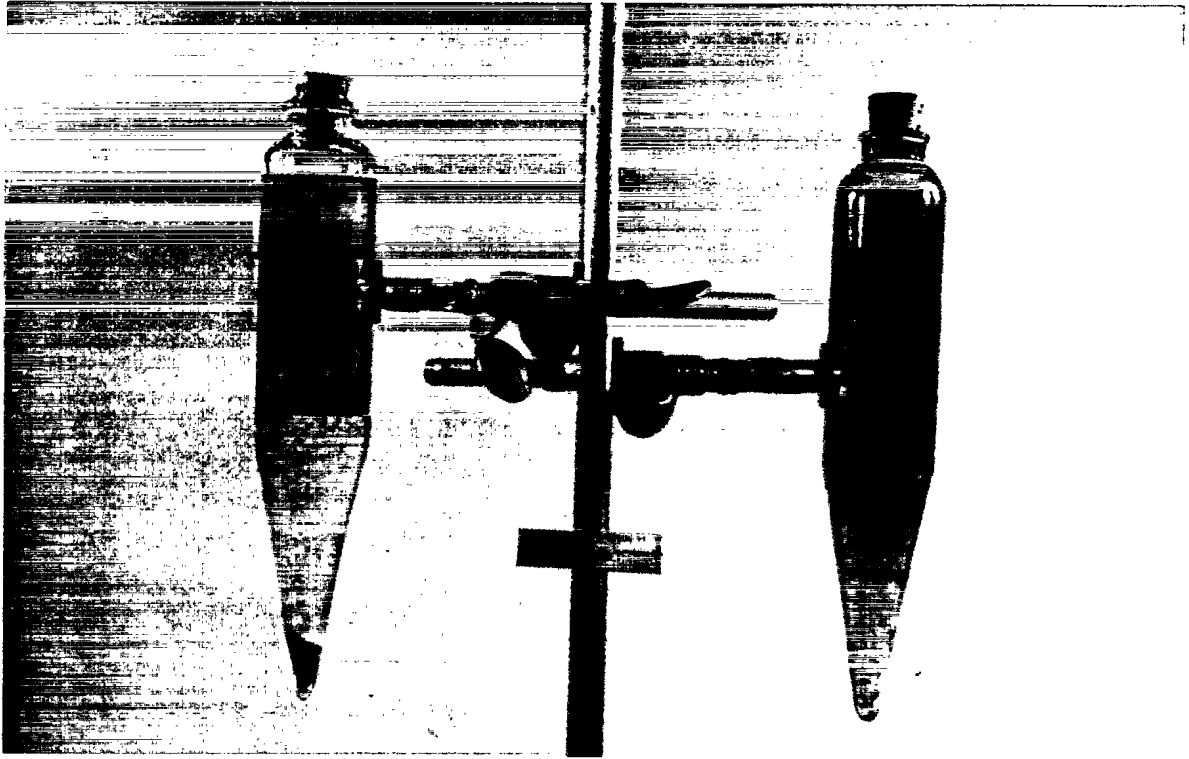
3.

SLIDE 3 - Water and Sediment Test showing water fungal mat at fuel/water interface and water layer with MBC.

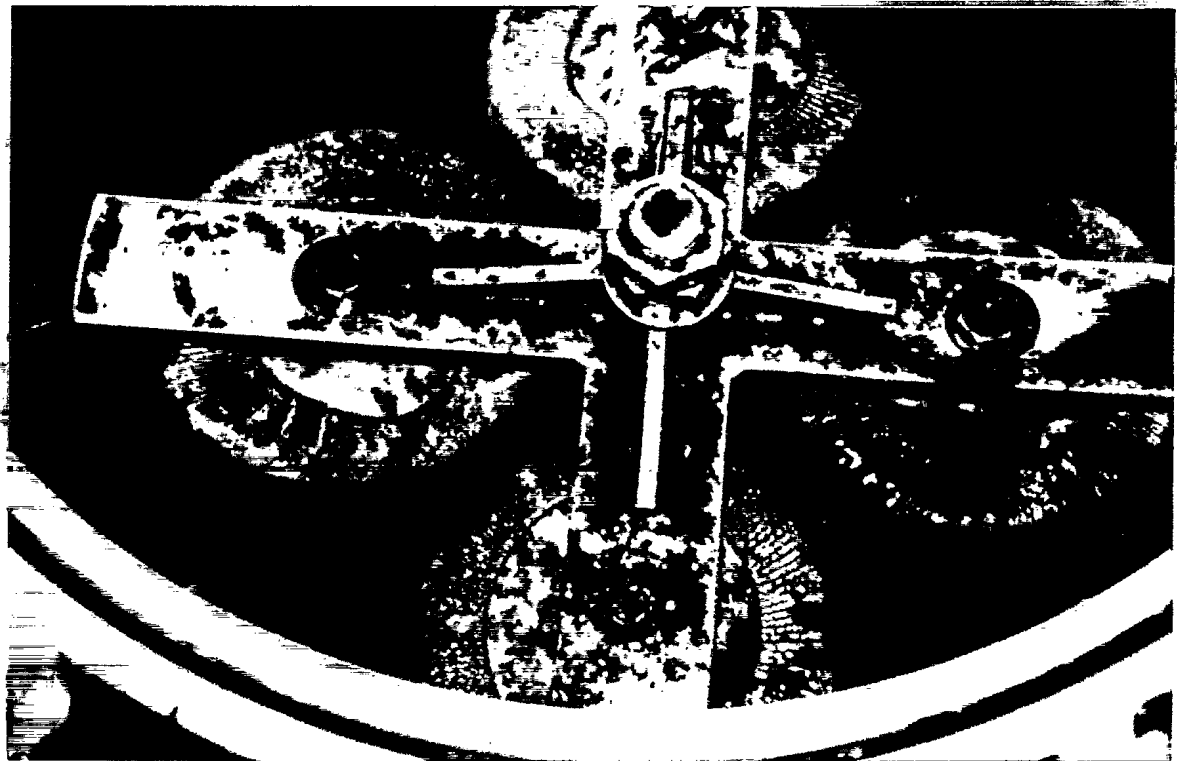
8.

SLIDE 8 - Coalescer/filter elements contaminated and blocked with MBC.
