DYNAMIC TESTING OF THE CT114 TUTOR EJECTION SEAT

November 1984

DCIEM NO. 84-C-46

D.R. Day

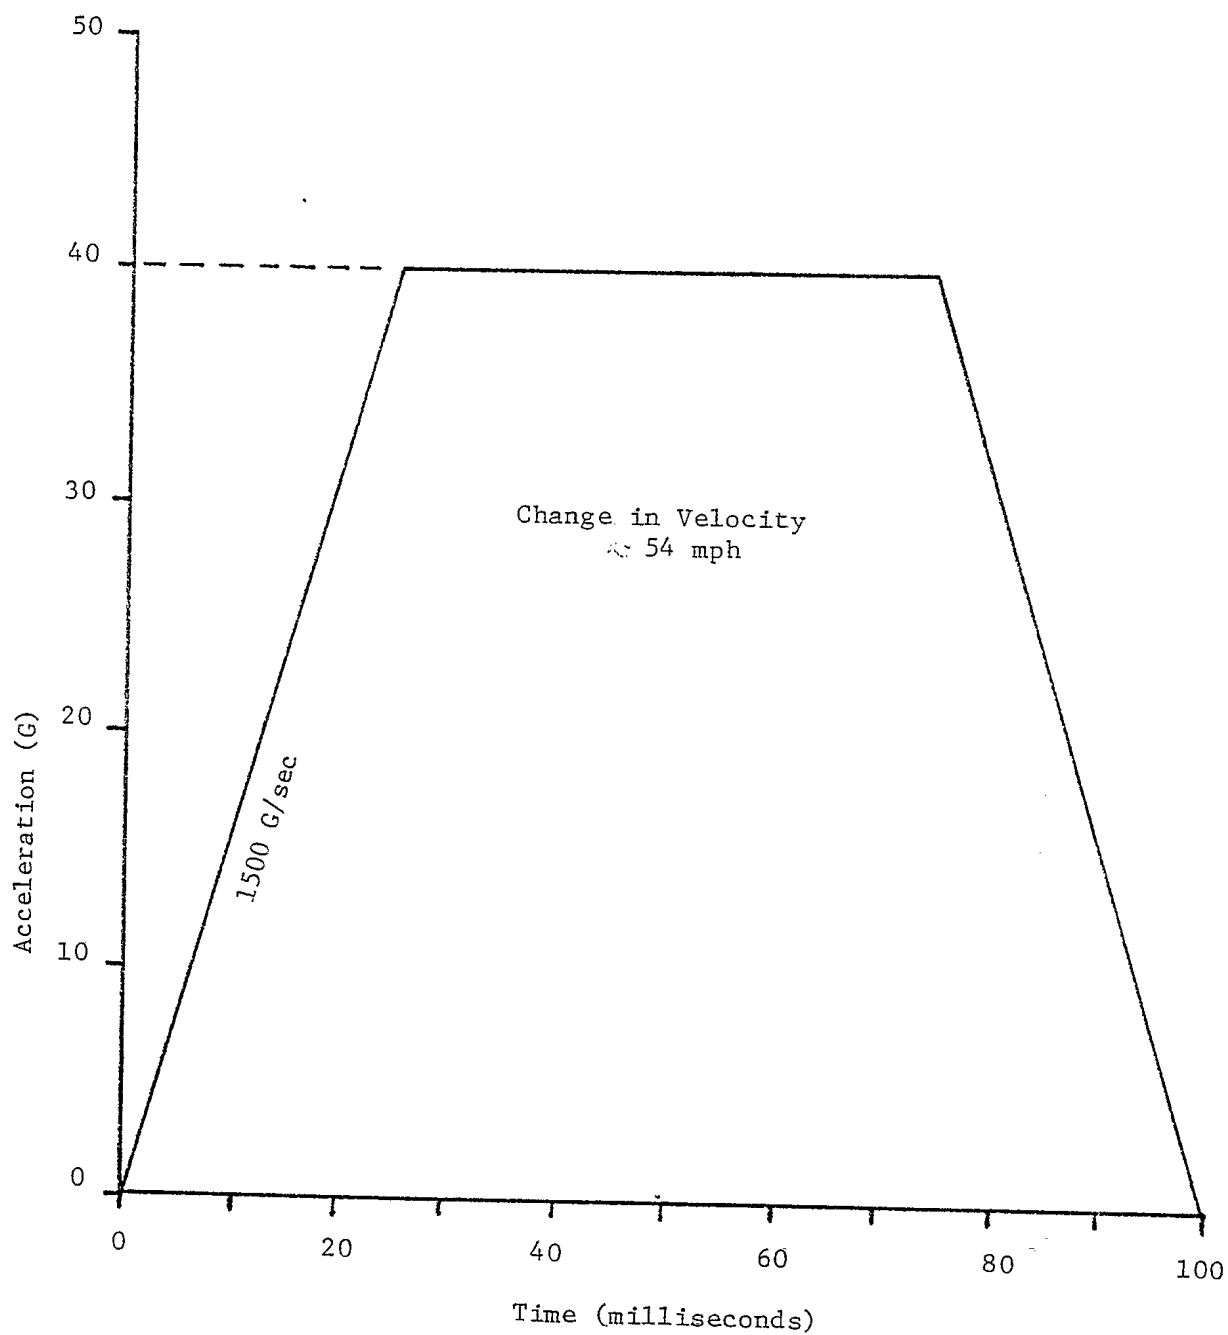
Figure 2: Recommended Longitudinal Design Crash Pulse as per MIL-S-18471F(AS)

The two most recent and relevant U.S. military specifications for ejection seats require dynamic testing at a peak acceleration level of 40 G's for frontal and $\pm 20^\circ$ impacts, resulting in a change in velocity of 54 MPH, as shown in Figure 2 (6,7). However, since the CT114 seat had not originally been designed to meet this particularly demanding specification, the decision was made to retain the peak acceleration requirement at 40 G's, but to reduce the velocity change from 54 MPH to one that would produce a 40 G deceleration in a typical longitudinal impact. The data from the Crash Survival Design Guides (3,4) were consulted for this purpose, and it was found that a 40 G longitudinal impact deceleration corresponds to a 97% CFO value, which, in turn, requires a velocity change of 36 MPH. Consequently, this was the targeted velocity change for all the impacts in the test program.
