# FASSET Refurbishment

DRDC Ottawa TM 2004-134

July 2004

This report covers the significant refurbishment events including items repaired, modifications and improvements, and unresolved problems. It provides a technical reference of knowledge collected as well as a record and explanation of refurbishment events. Other topics covered include test equipment, maintenance procedures, lessons learned, and future work.

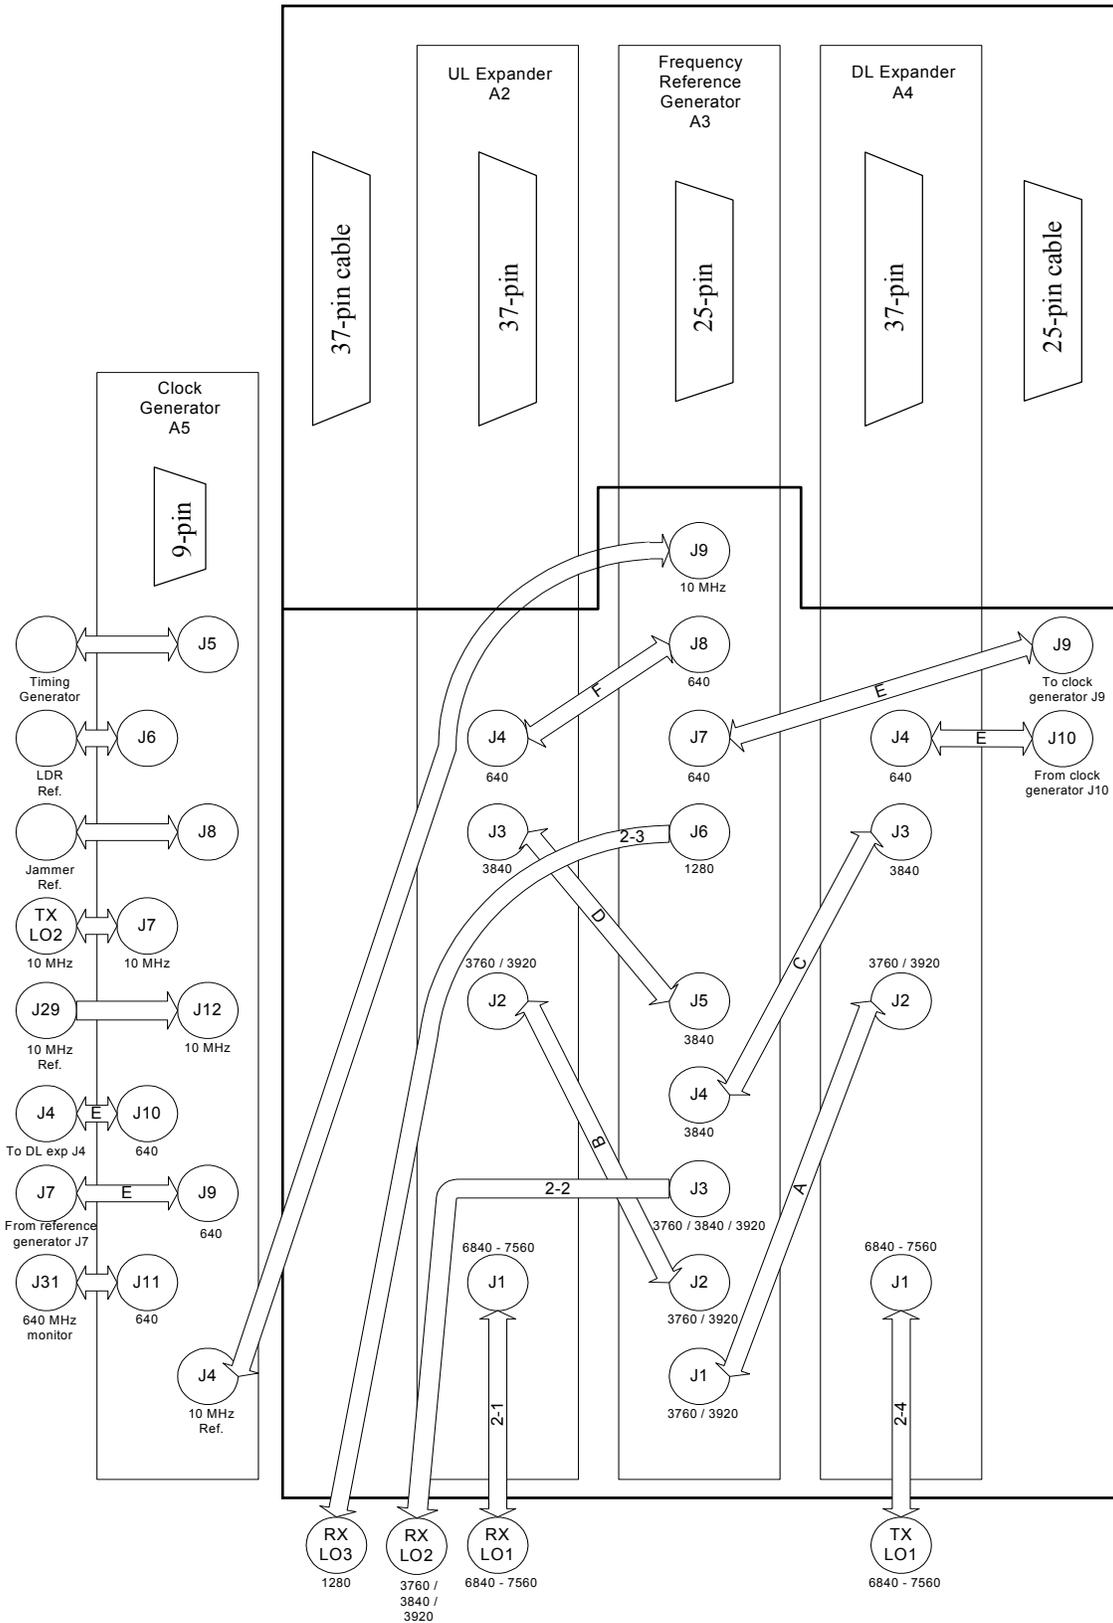
**Figure 8 Payload Frequency Synthesizer connection diagram**

During testing, a discrepancy between schematics and actual connections was noted with regards to the payload Frequency Synthesizer. In Figure 8 (this figure depicts the connections as they currently exist), the SMA coaxial cable connected to J1 on the Frequency Reference Generator (module A3) should be connected to J2, and the cable at J2 should be connected to J1. Similarly, the cables connected at J4 and J5 should also be swapped. From the point-of-view of the Uplink and Downlink Expanders there is no difference because the signals on the swapped connectors are functionally identical.
