The effects of decaying marine organisms on the corrosion of copper-nickel alloys in sea water

D. R. Lenard and R. R. Welland

Defence Research Establishment Atlantic Dockyard Laboratory (Pacific)

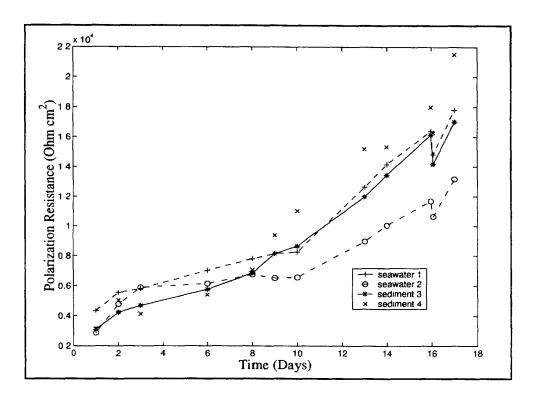
• Polarization resistance measurements for 4 specimens of 70-30 Cu-Ni that, at this point, had been continuously exposed to flowing sea water. Observe the decrease in polarization resistance (increase in corrosion rate) that occurred on Day 16, one hour after the sea water delivery pumps were changed. The switchover introduced a small amount of sulfide (from marine organisms that have died in the stagnant line) into the water in the tank for a few minutes. Note that, in this case, the interruption in the development of the protective film is temporary and any damage is repaired by continuing exposure to clean sea water.

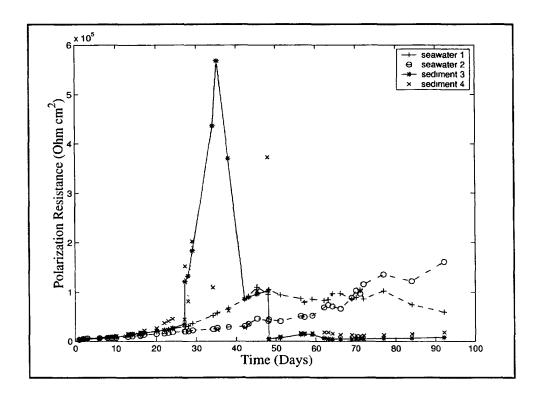
Polarization resistance measurements for 4 specimens of 70-30 Cu-Ni. Until Day 27, all specimens were exposed to clean, flowing sea water, with the brief exception of the introduction of a small amount of sulfide on Day 16, as described in a previous slide. On Day 27, specimens 3 and 4 were lowered into organic debris that had been allowed to accumulate at the bottom of the exposure tank. The immediate increase in polarization resistance (decrease in corrosion rate) is associated with the lack of oxygen in the sediment. The sediment was loosely packed and had little effect on the solution resistance (iR drop). On Day 48, specimens 3 and 4 were lifted back into the flowing sea water.

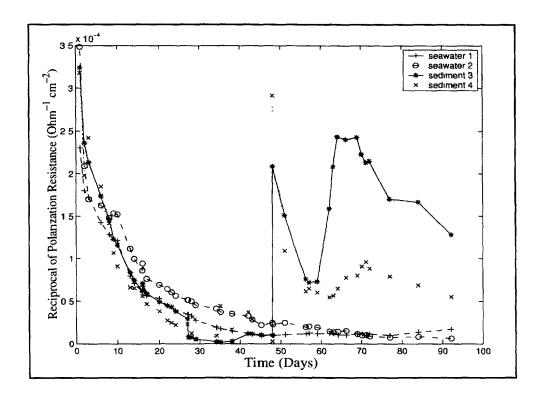
• Same data as previous graph, but y-axis converted to reciprocal of polarization resistance, which is directly proportional to corrosion rate. Note the sharp increase in corrosion rate when specimens 3 and 4 are re-exposed to flowing sea water. They show at least an order of magnitude higher corrosion rates than the control specimens that were continuously exposed to flowing sea water. Furthermore, these specimens do not develop protective films as quickly as they did when first exposed to sea water at the start of the experiment Fully protective films did not develop even after another 45 days of exposure to flowing sea water.

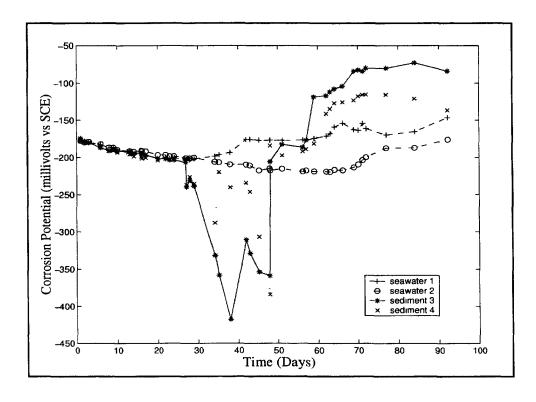
Plot of corrosion potential for the specimens described on the previous two pages. The shift in corrosion potential for specimens 3 and 4 between Day 27 and Day 48 results from the anaerobic conditions in the sediment. The fluctuations in corrosion potential during this time period suggest the possibility of biological activity within the sediment.

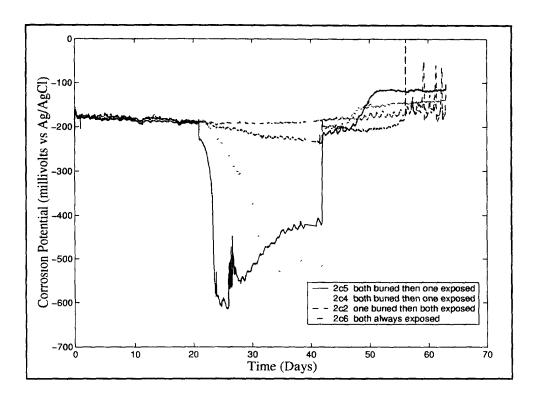
• As observed during the polarization resistance measurements, there was a marked shift in the corrosion potential for the two pairs of specimens for which both members of the pair had been lowered into the debris between Day 21 and Day 42. No such dramatic shift was observed for any of the three pairs in which only one specimen was lowered into the debris or for the control. The sharp spikes in the potential for specimen 2c2 (dotted line) after Day 56 were caused by a sea cucumber (Eupentacta quinquesemita) crawling up and down the reference electrode.

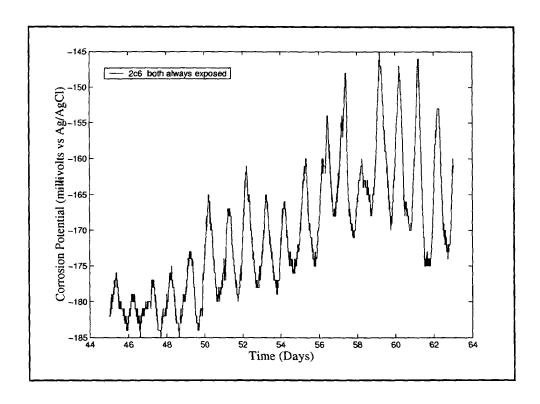
• Blow up of the region of the previous graph between Day 45 and Day 63 for the control cell (2c6). The daily variation is presumed to be caused by variations in the oxygen concentration as a function of biological activity.

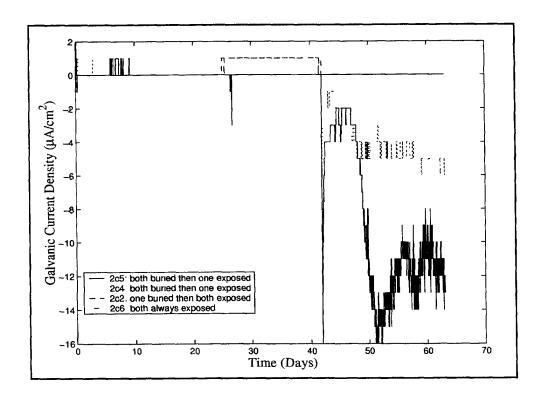
• Substantial galvanic current was observed for the two pairs of specimens in which both members of the pair had been buried in the organic debris (2c4 and 2c5). This current was observed as soon as one member of each pair was lifted back into the flowing sea water and persisted throughout the remainder of the experiment. The direction of current was determined to be such that the specimen that remained buried in the sediment suffered accelerated corrosion. This conclusion was supported by the fact that the specimens in these pairs that were lifted back into the sea water were rapidly fouled, indicating that the cathodic protection resulting from the galvanic current prevented the release of copper ions, which have biocidal properties, from these specimens
