ASSESSING THE LONG TERM DURABILITY OF GLASS FIBRE COMPOSITES

Alan J. Russell

Esquimalt Defence Research Detachment
CFB Esquimalt, Bldg. 199
PO BOX 17000 STN FORCES
VICTORIA, BC V9A 7N2
Canada

This paper describes part of a test program being carried out to substantiate the long term durability of glass fibre re-inforced composites for use in sonar domes and other Naval applications. This program, which was designed to encompass the combined effects of fatigue loading, impact damage and the marine environment, is generating data for material selection purposes as well as providing insight into degradation mechanisms. The testing reported here includes cyclic loading of 9 mm thick woven fabric composite laminates loaded in four point bending at R-ratios of $R = 0.1$ and $R = -1$ (fully reversed) as well as under bi-axial conditions (also at $R = 0.1$). An approach for predicting impact resistance is described and some results are presented which show the level of protection afforded by several different elastomeric coatings to 10 mm thick panels subjected to low velocity impact. In addition, the nature of the micro-cracking observed in two different glass fibre materials subjected

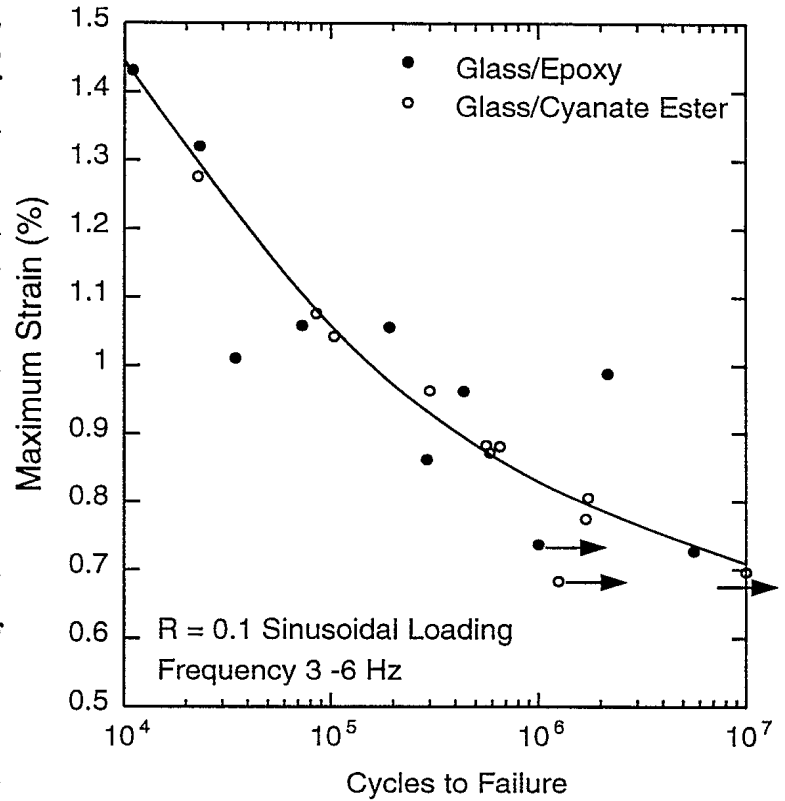
Figure 3. Strain - N curve for R=0.1 specimens.

Beam Tests. The results of the $R = 0.1$ fatigue tests are shown in Figure 3. The fatigue lives are plotted against the tensile strain corresponding to maximum load at the start of each test since all of the failures initiated on the tensile sides of the specimens. Similar data for the $R = -1$ tests are plotted in Figure 4. Because of the reverse bending and the almost identical tensile and compressive moduli, both sides of the specimens experienced alternating tensile and compressive strains of the same magnitude. Consequently, there was no difference between the top and

bottom surfaces of the test specimens and no preference for initiation of failure. The data in Figures 3 and 4 shows that there was no significant difference in fatigue behaviour between the two materials.

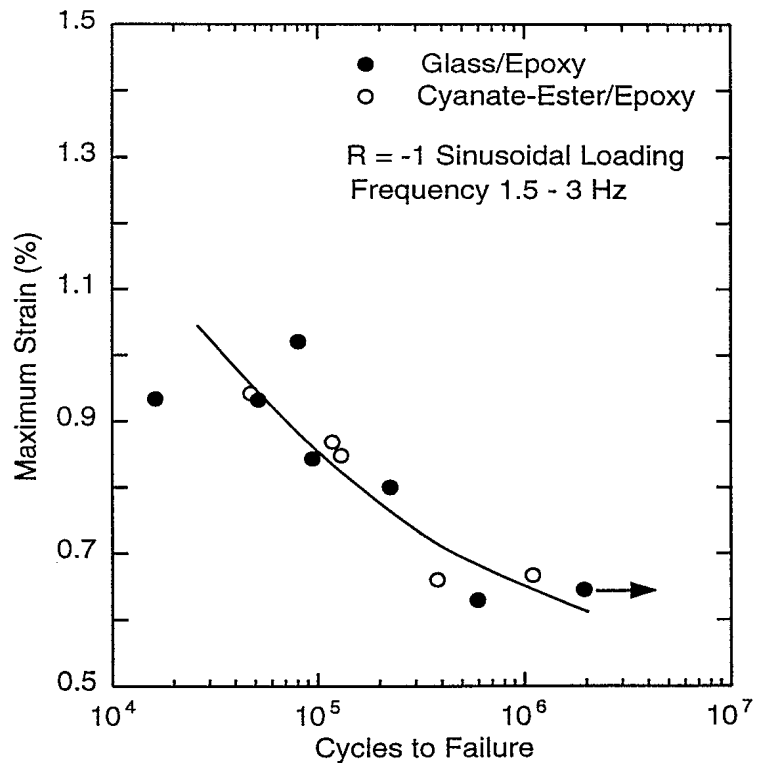
Figure 4. Strain - N curve for R=-1 specimens.

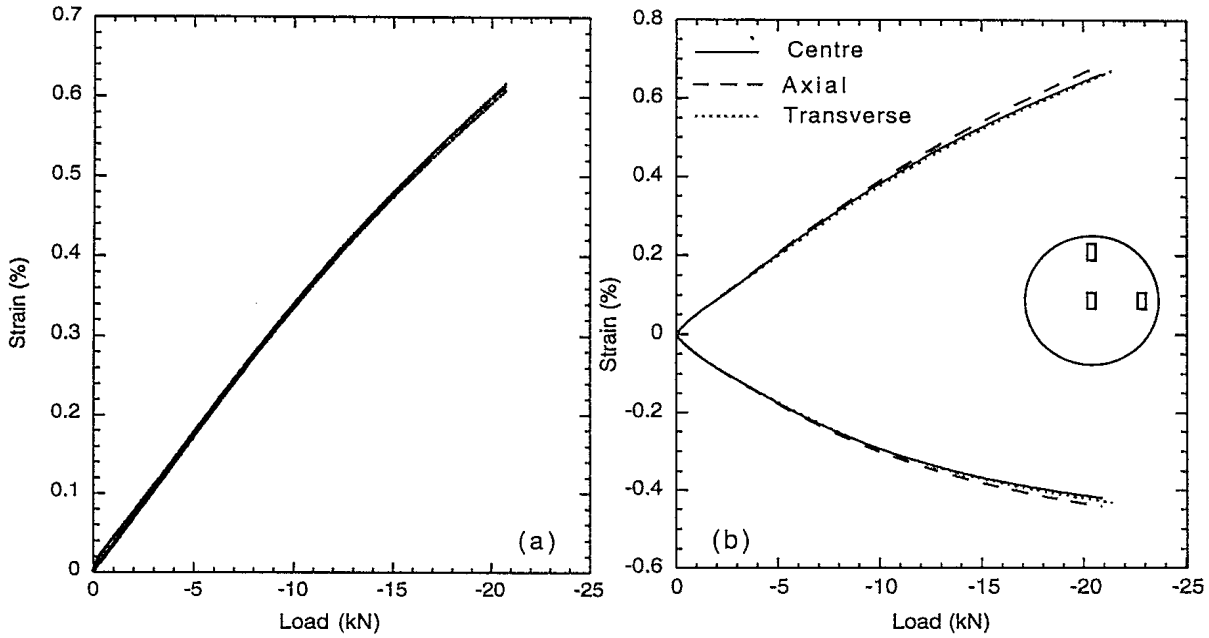
Figure 5. Load - Strain curves for bi-axially loaded panels. (a) 0, 45 and 90° strains at centre of panel, tensile side. (b) 0° strains at 3 positions, both sides.

Plate Tests. The strain gage measurements provided some insight into the nature of the loading actually present in the plate tests. The three outputs from a 0/45/90 rosette gage mounted at the centre of the tensile side of a plate are plotted against load in Figure 5 (a). The three curves fall on top of each other indicating that the bi-axial strains are essentially independent of direction. The uniformity of the strain field within the area of the inner loading ring was investigated by loading another plate in three different positions. Back to back gages were used to measure the surface strains at the three positions shown in the inset of Figure 5 (b). The good agreement between the three curves shows the uniformity of the strain field over the portion of the plate lying within the loading ring. A comparison of the magnitude of the tensile and compressive strains in Figure 5 (b) reveals that significant diaphragm stresses develop in the

plate as the load-strain curves become non-linear.

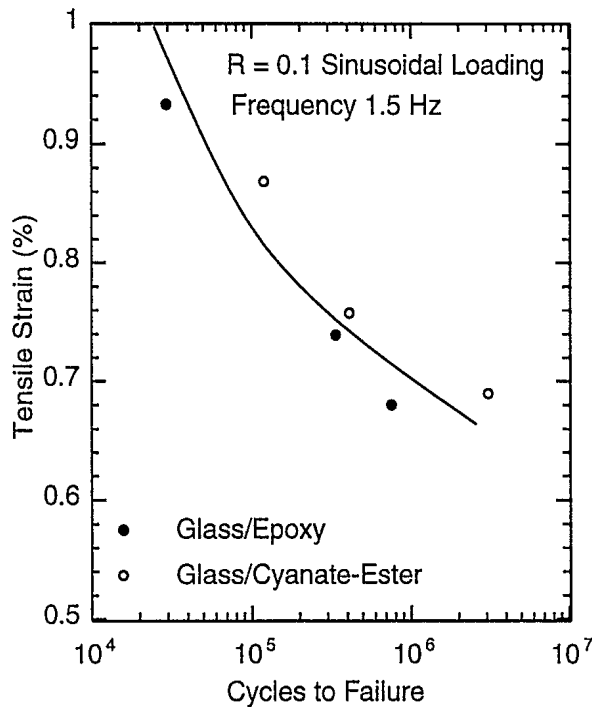
Figure 6. Bi-axial fatigue data.

Some results from the plate tests are shown in Figure 6. The number of cycles to failure for six different test plates is plotted against the maximum tensile strains measured at the start of each test. All of the failures initiated on the tensile side of the plates and all were very similar in

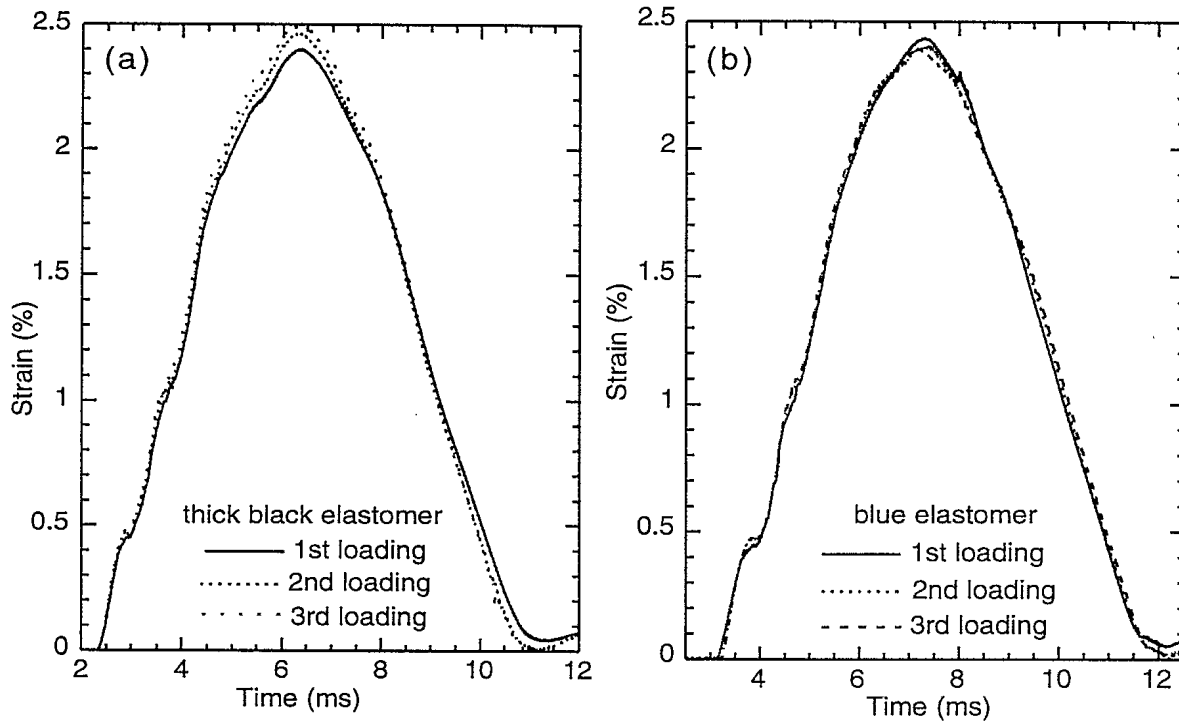
Figure 11. Comparison of back surface strains on elastomer coated panels during first, second and third impacts. (a) 12.7 mm of polyurethane. (b) 12.7 mm of PVC.

Initiation of failure in the unprotected panel can be seen as the small drop in strain from 3.3% to 3.0%. (The sharp decrease in signal at 6 ms is caused by failure of the gage). All three elastomers produced similar reductions in the magnitude of the back surface strain although the natural rubber gave the greatest reduction in loading rate because of its lower modulus. The ability of the other two elastomers to withstand repeated impacts is compared in Figure 11. While the peak strain measured on the back of the

panel coated with the polyurethane increased to 2.46% (from 2.40%) on the second impact and to 2.52% on the third impact, the effectiveness of the PVC did not appear to deteriorate and no evidence of crushing or denting was apparent. The strain - time curves in Figure 11 also show the excellent reproducibility of the impact response achieved in these tests.
