DETECTABILITY OF KNOWN CRACKS UNDER FASTENERS USING ULTRASONIC IMAGING

DCIEM No. 98-TM-08

**DETECTABILITY OF KNOWN  
CRACKS UNDER FASTENERS  
USING  
ULTRASONIC IMAGING**

# Detectability of Known Cracks Under Fasteners Using Ultrasonic Imaging

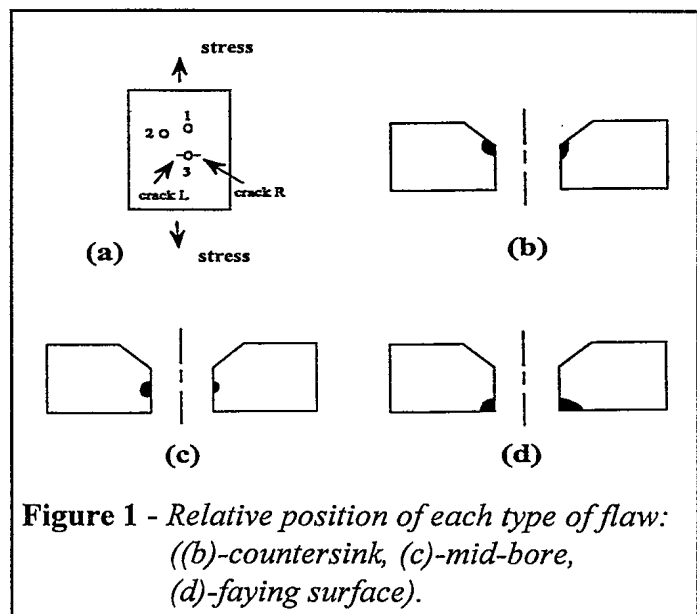
**Figure 1 - Relative position of each type of flaw:  
(b)-countersink, (c)-mid-bore,  
(d)-faying surface.**

Three 0.258" diameter countersunk fastener holes were drilled through 12x4x0.330" pieces of 7075-T651 aluminum alloy plate. Fatigue cracks were produced in most of these using electro-discharge machining and tensile loading. They were generated such that the propagation direction was normal to the principal tensile stress axis (Figure 1(a)). For a given coupon, the depth of each flaw was controlled such that it was generated either at the bottom of the countersink (CS), at the mid-bore (MB) or at the faying surface (FS) of each hole as shown in Figures 1 (b), (c) and (d), respectively. Several coupons were left unflawed (MS). Eighty-two coupons (58 with cracks and 24 without cracks) were
