EDDY CURRENT IMAGING USING MULTI-FREQUENCY MIXING METHODS FOR AIRCRAFT
STRUCTURAL INTEGRITY VERIFICATION

EDDY CURRENT IMAGING USING MULTI-FREQUENCY MIXING METHODS FOR AIRCRAFT STRUCTURAL INTEGRITY VERIFICATION

B.A. Lepine, Capt
Air Vehicle Research Detachment
National Defence Headquarters
Ottawa, Canada K1A 0K2

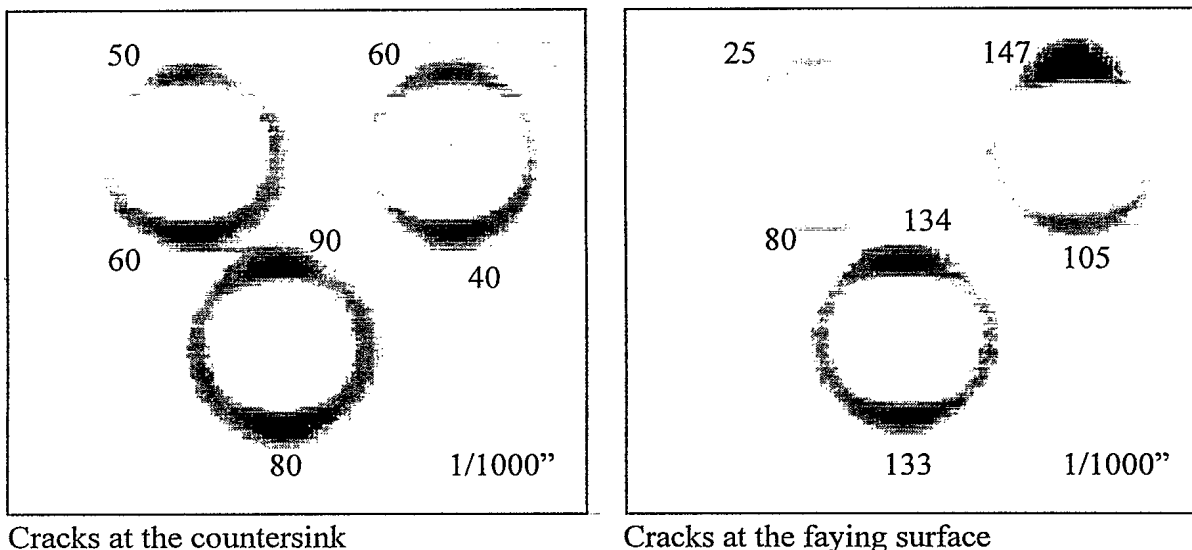
The dual frequency method was capable of detecting countersink cracks with lengths well within the shadow of the fastener head. As shown in the left side of Figure 7, the smallest detectable crack was 0.040" long from the bore. Faying surface cracks are deeper in the material, hence only those over 0.100" long could be detected. Note that colored images are more effective at discerning the flaws in both cases below.

Figure 7. 1 kHz-2 kHz mixed frequency scans of specimens with cracks under fasteners

The advantages of frequency mixing are evident in the images of the corrosion sample shown below. Whereas the single frequency scan in Figure 4 is cluttered and dominated by the fastener signals, the mixed frequency scan of Figure 6 amplifies the corrosion signal and reduces those from the fasteners. The corrosion in this case appears as dark rings around the fasteners. The method's effectiveness is also illustrated in Figure 7 where the crack signals are clearly evident as dark areas adjacent to every hole. In both cases, the severity of the flaw (depth, or radial length) is related to the intensity, or the darkness, of the signal. Note that the fasteners cannot be completely clipped out since their signals are too large to allow a D_{offset} of zero during the mixing procedure. The method was also used on specimens that had fatigue cracks at the faying surface, with the results also shown in Figure 7. The crack sizes are given in the figures.

It is worthwhile noting that the indicated areas of corrosion, crack lengths and fastener head sizes in the C-scans are larger than their actual size due to the large diameter of the probe. The crack indications are especially "smeared out" due to the diffusive nature of the eddy currents. Better resolution can be achieved from smaller probe diameters, but this usually results in weaker signals and less depth of penetration. Furthermore, since these eddy current images are only amplitude representations, they do not display information about the entire signal. The phase changes, for example, can provide complementary information when displayed alone, and enhanced images when properly combined with the amplitude data. In this study, however, this was not attempted since the phase images were very noisy due to the very low frequencies and subsequently low sensitivities. In their present state, the images are useful when the inspection is set up and calibrated to detect a pre-determined range of defects, presented in terms of a meaningful color or gray scale, in a constrained configuration. Therefore, with calibration scans, the method could be used to determine a threshold intensity value above which any indications in future scans on similar inspectable components would signify corrosion or cracks beyond those acceptable limits.
