# Using the Foerster Rivet Check system to detect cracks under installed fasteners

Technical Memorandum

DCIEM TM 2000-057

May 2000

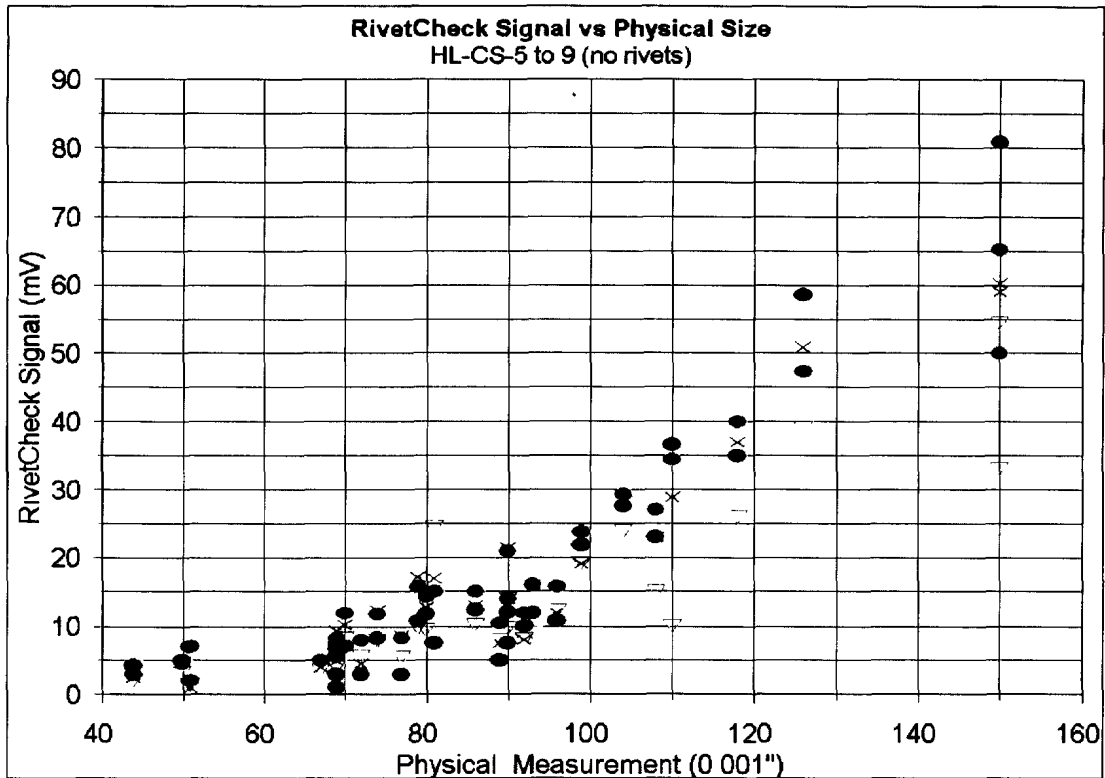
**Figure 6 - Rivet Check Signal vs Flaw Size With and Without Titanium Fasteners: Countersink Flaws**

Results of the inspections of the holes with countersink flaws are shown in Figure 6. The amplitude of Rivet Check signal (millivolts) versus known crack size (0.001") at each of four different depth settings is displayed. Flaws between 0.040" and 0.150" were detected readily and the resulting indication was proportional to flaw size. The system also correctly identified the relative position of the cracks. It was found that under these conditions the system was unable to detect cracks smaller than ~0.040". The presence of titanium rivets did not interfere with the ability to detect flaws, but the amplitude of the signal produced by the system was reduced by a factor of two.

Reliable detection of countersink flaws under the head of steel rivets was virtually impossible. It was very difficult to center the test head and the system did not automatically detect any flaws. Peaks on the display indicated that flaws were distributed randomly and not at their known locations. The interference caused by the presence of ferrous fasteners when inspecting using other eddy current devices has been observed in previous investigations (3).
